Bowden Mansion Contract, Restoration of Victorian Encaustic & Geometric tiled floor. Grade 2 listed.

Bowden Mansion House.

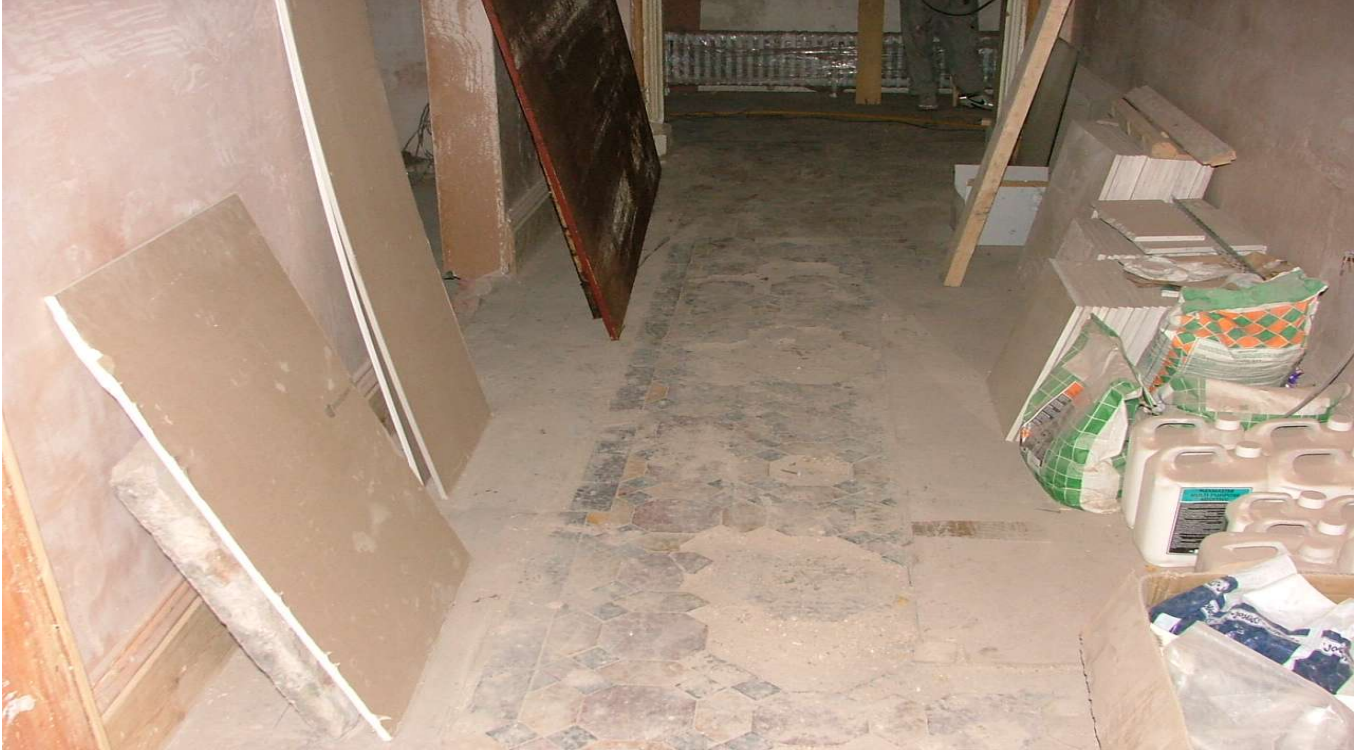
Materials stacked over Stair-side damaged section of Victorian encaustic & geometric tiles.

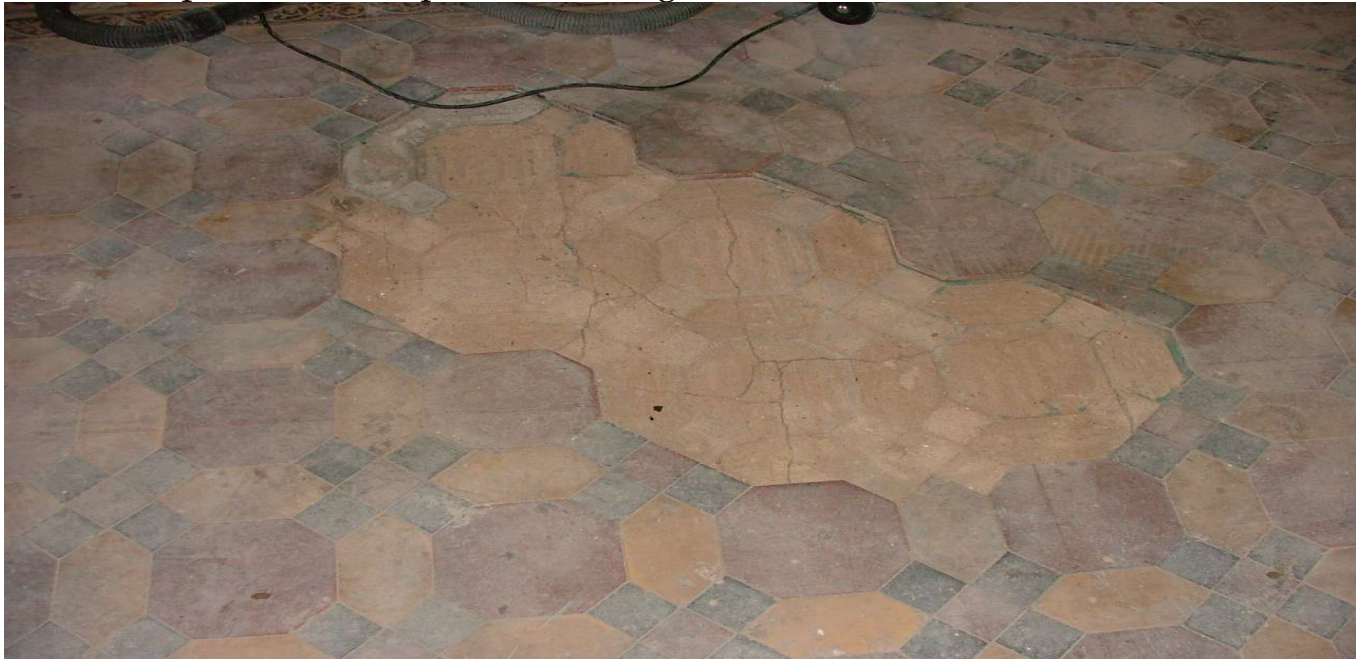
Patch of missing tiles and cracked screed.

To remove the broken & damaged tiles and lift the large sections of tiles we employed 4 Exakt saws fitted with fine diamond blade's approx 1mm thick the machines are fitted with vacuum hoses as the dust from cutting into lime screed is very fine, masks are also worn.

The Exakt saws are used to cut around and isolate the intact geometric and encaustic tiles as these will be used to restore the least damaged hall-way floor.

Exakt saws are used as the blade cuts a few mm into the under-lying screed and so prevents any transference of impact and vibration whilst the recovery process goes on.

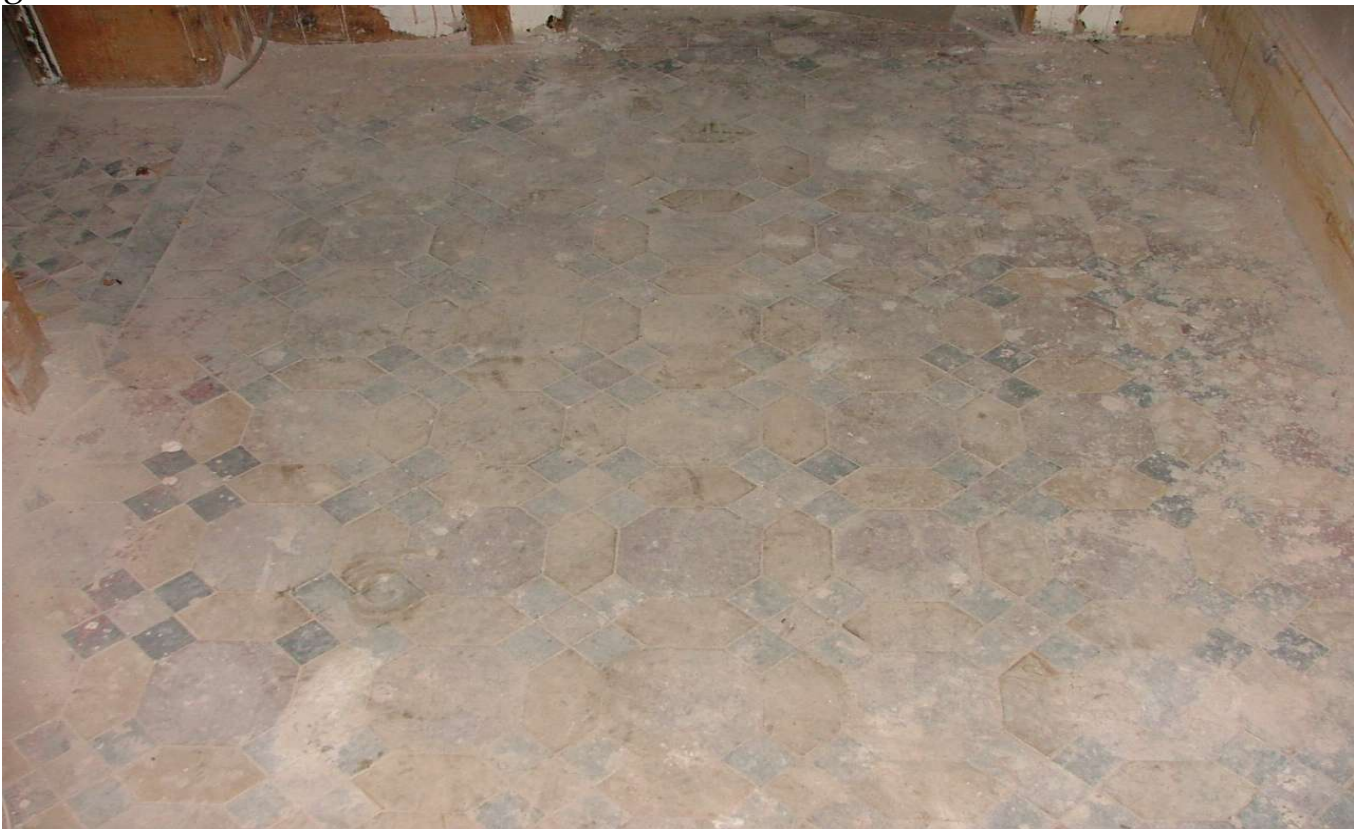
Part of the main floor after being cleared prior to restoration.

Fein super-cut machines are also used with a variety of attachment's to tease the tiles out of the floor.

We also use the Fein super cut to grind areas of the under-lying lime screed down to a level which will accept a layer of flexible adhesive and a replacement tile.

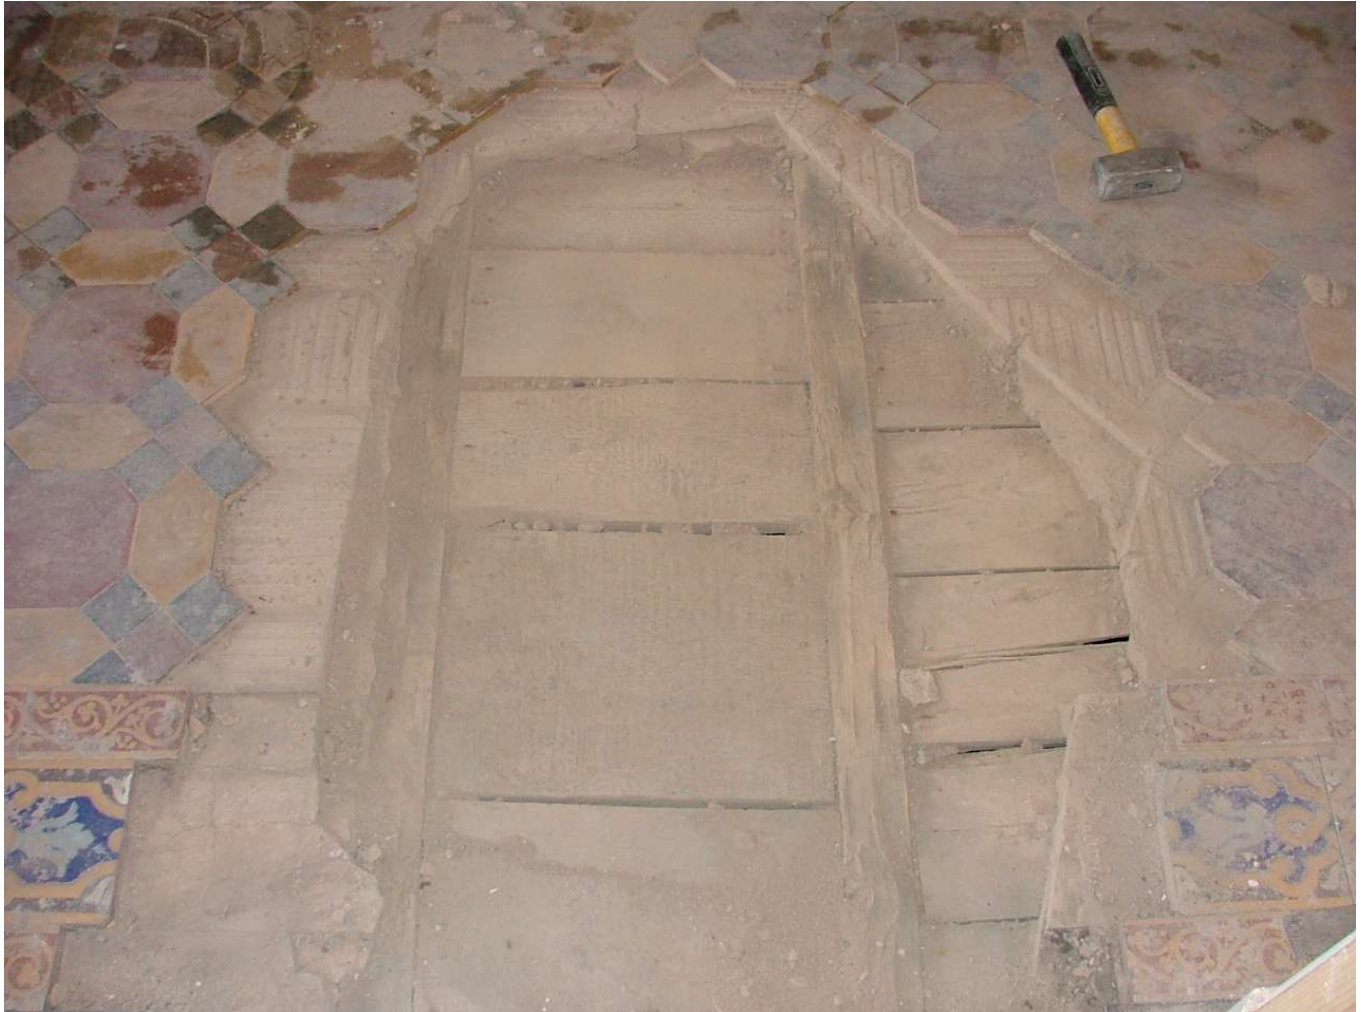
Some of the patches were so damaged we had to take the screed out to the underlying wood battened floor. To counteract movement a screed was laid that had glass fibres throughout the mix, once cured a latex leveller is poured to the correct height to accept a tile & adhesive bed.

Patch taken back to the wooden battens. Sharp edges are from the Exakt saw!

This particular section was also shored up underneath to prevent a further drop in the floor, a section of joist was replaced with a metal section.

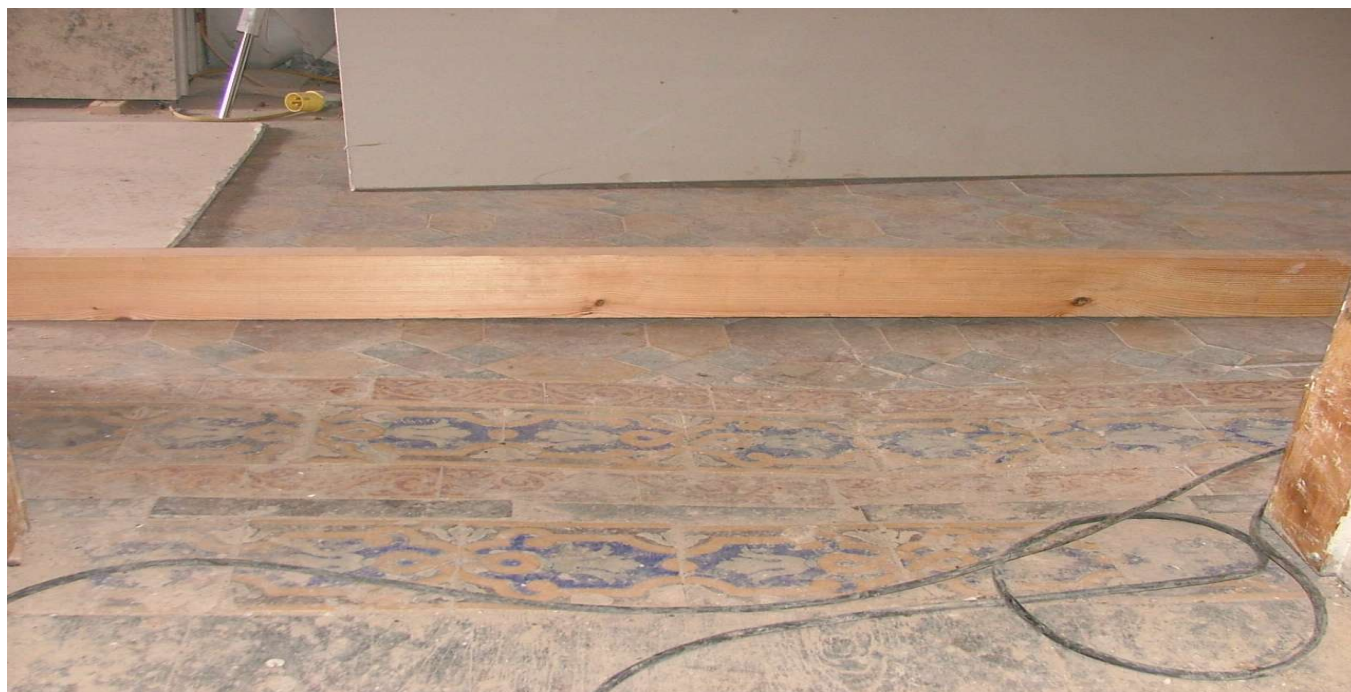
The following pictures show the floor patch above as a dip in the floor prior to be lifted, the length of wood shows how much the floor had dropped.

Dip in floor as demonstrated by the length of wood.

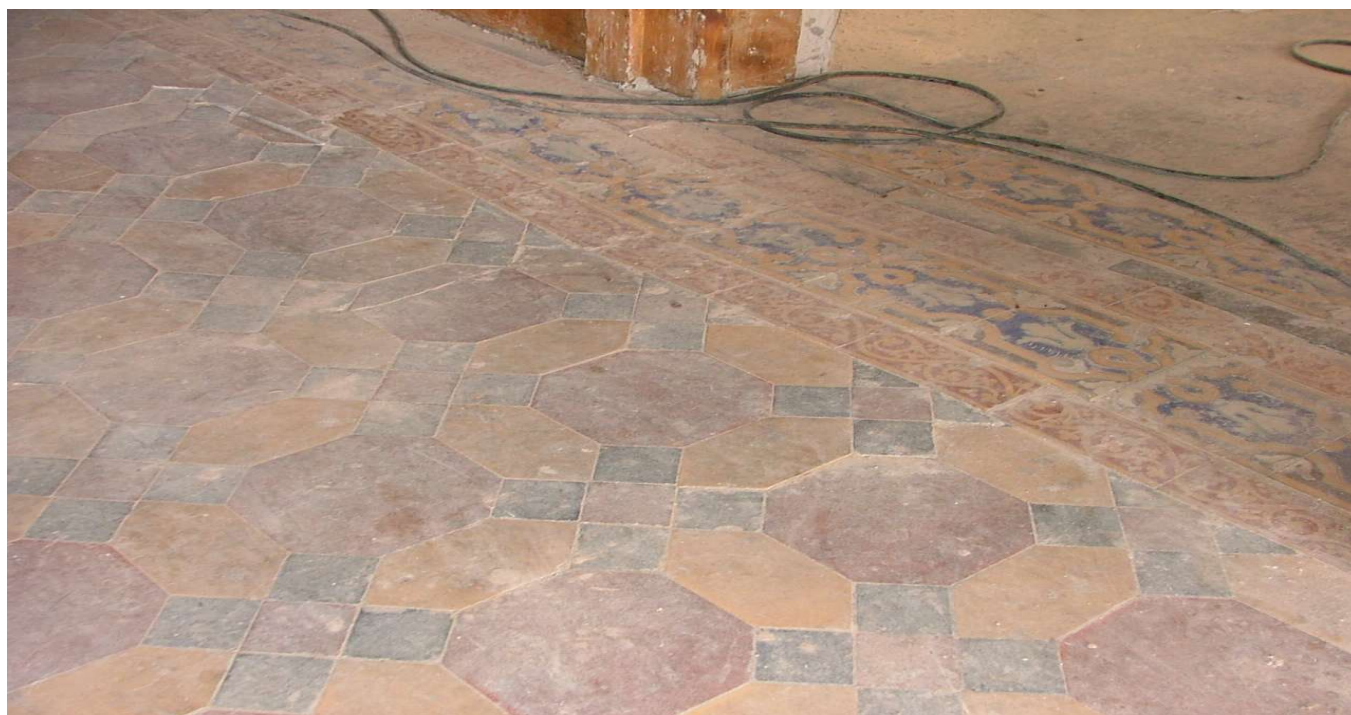
Dip from other direction.

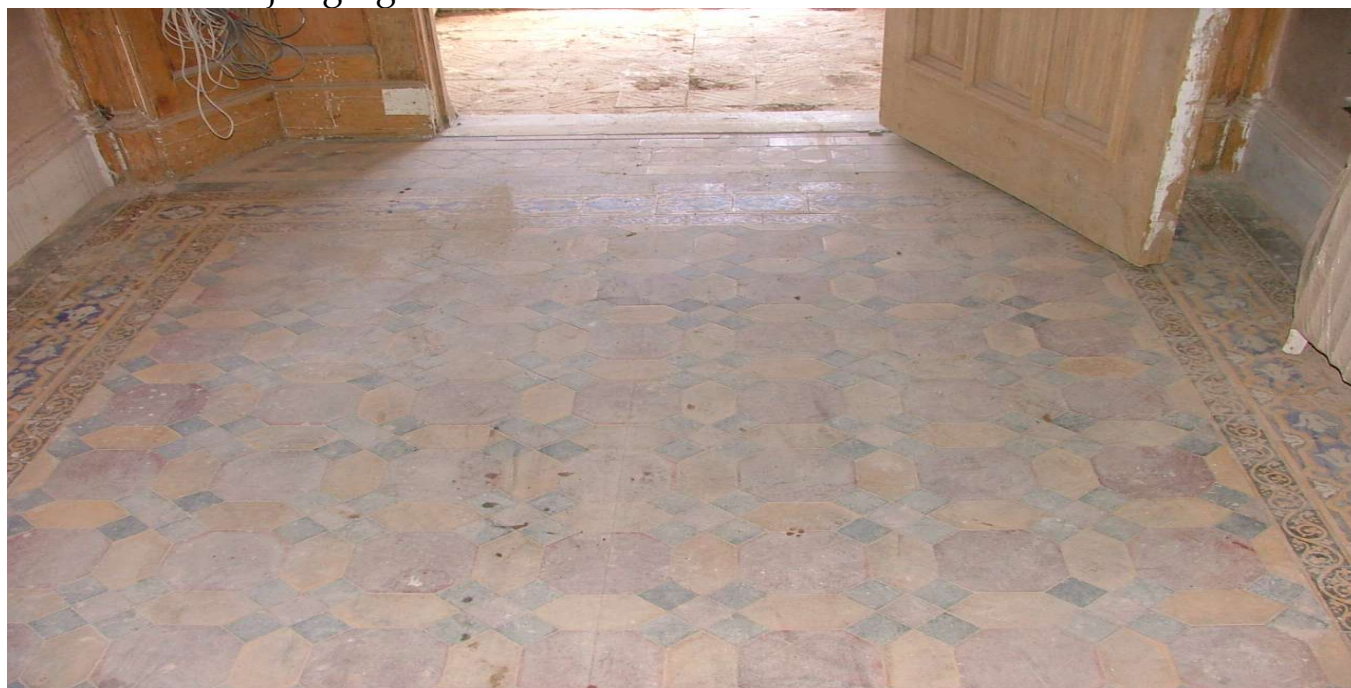
Pictures below show the Victorian encaustic & geometric tiled floor before it is cleaned ,first picture also shows part of the porch floor with removed tiles scars, the tiles had been removed before our Co arrived it appears they were post 2<sup>nd</sup> world war tiles judging from the remnants.

Bowden Mansion floor prior to full restoration showing porch top of picture.

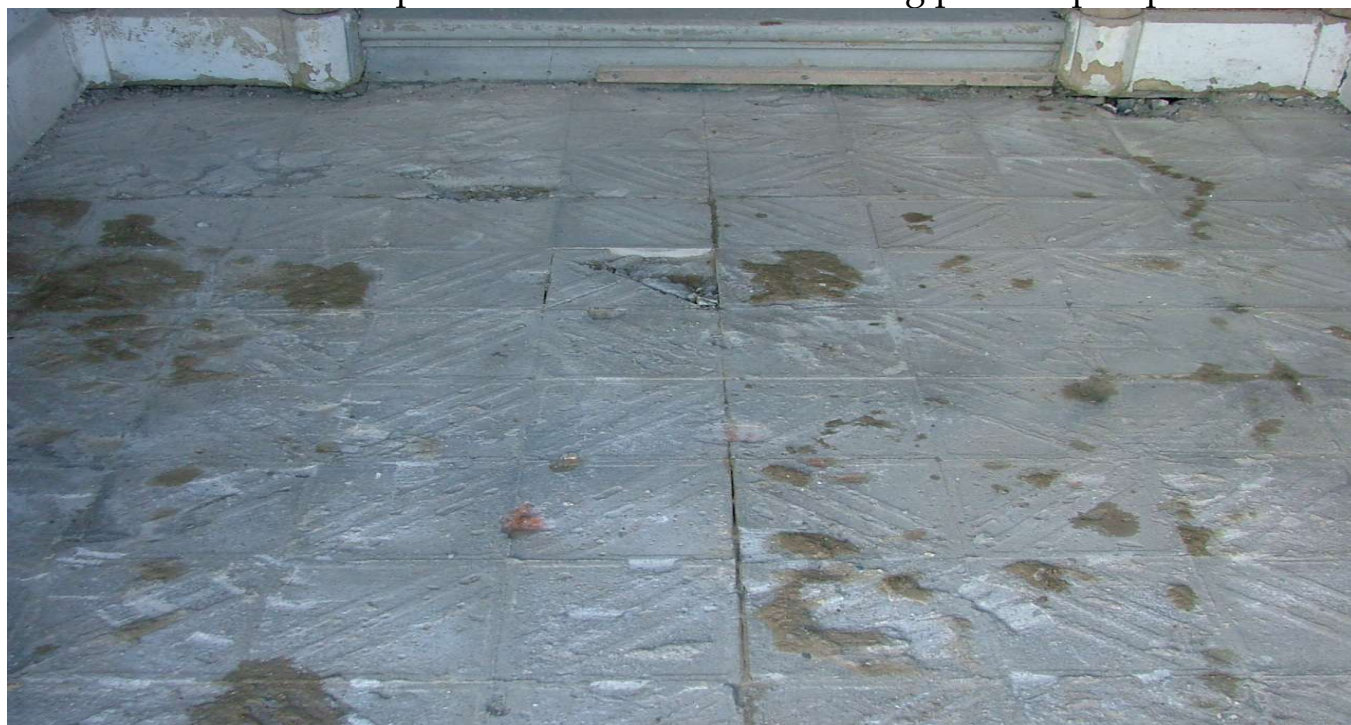
Porch 2 showing tile scars.

Porch 2 had already had it's non-descript tiles removed = plain red, Porch 1 tiles were again post-war and were red 6 inch x 3 inch tiles laid in a herringbone fashion.

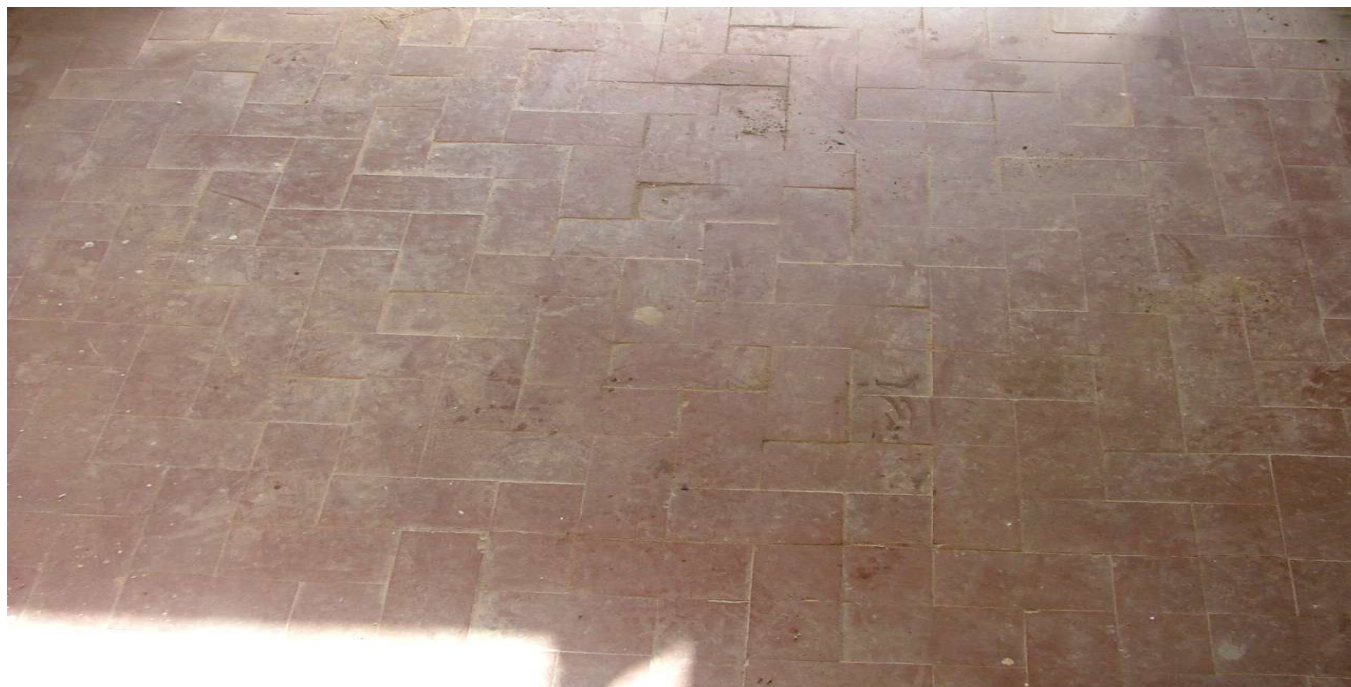
Red 6x3 tiles in Porch 1 Bowden.

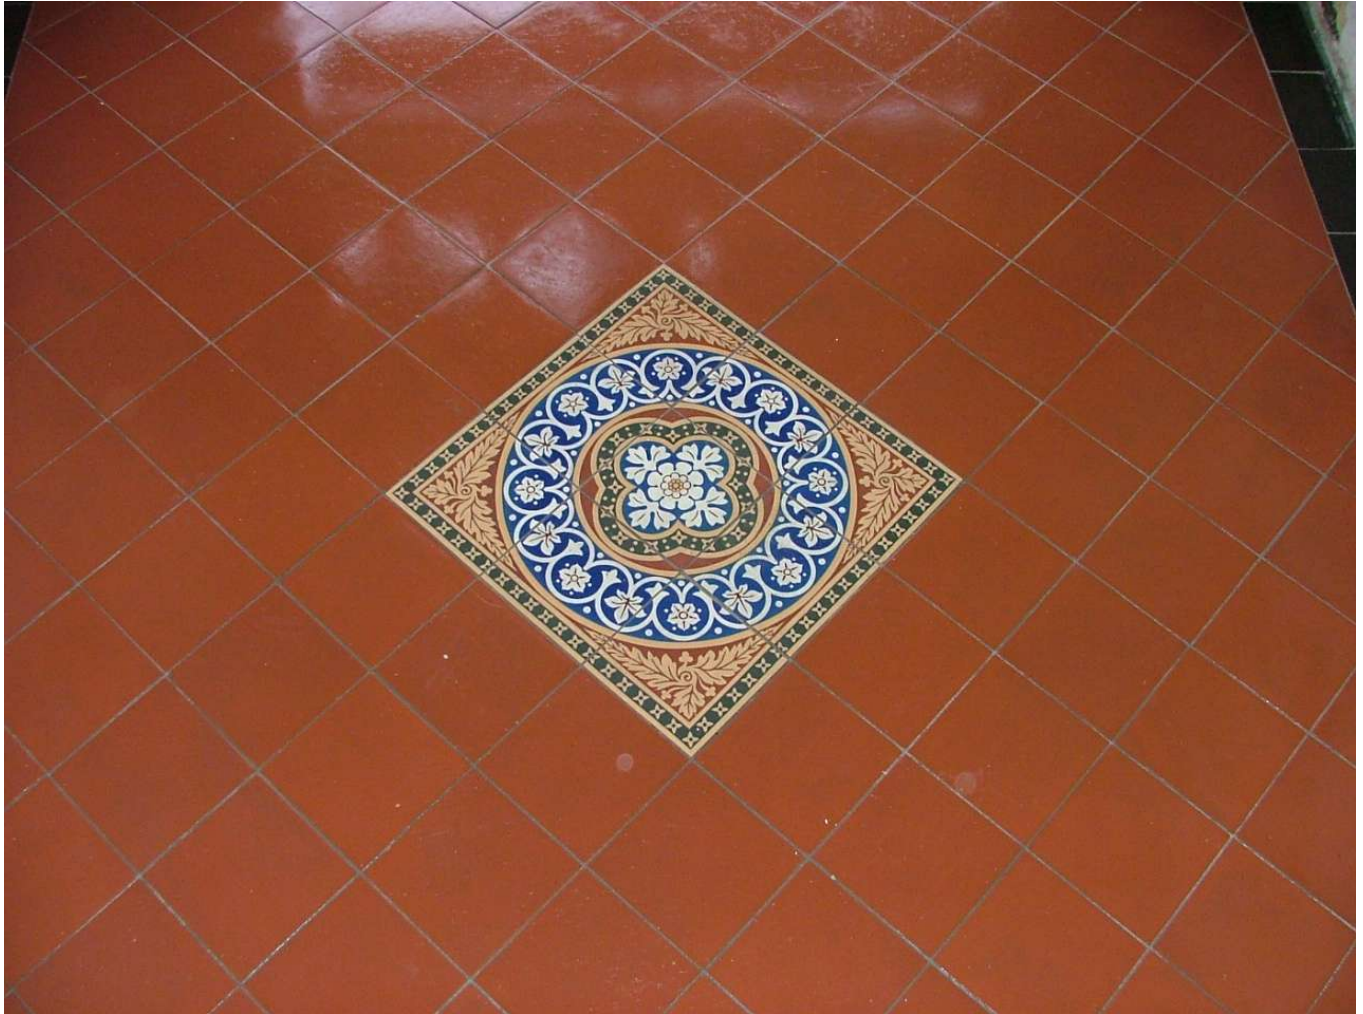
The Encaustic panel above is a fine feature of the porch floor, panel made by Craven Dunnill tile of Jackfield.

We had agreed between the C.O. & the client that a plain red tile with a black band from Craven Dunnill Jackfield with an Encaustic panel made by the same Co would be used at both porch entrances.

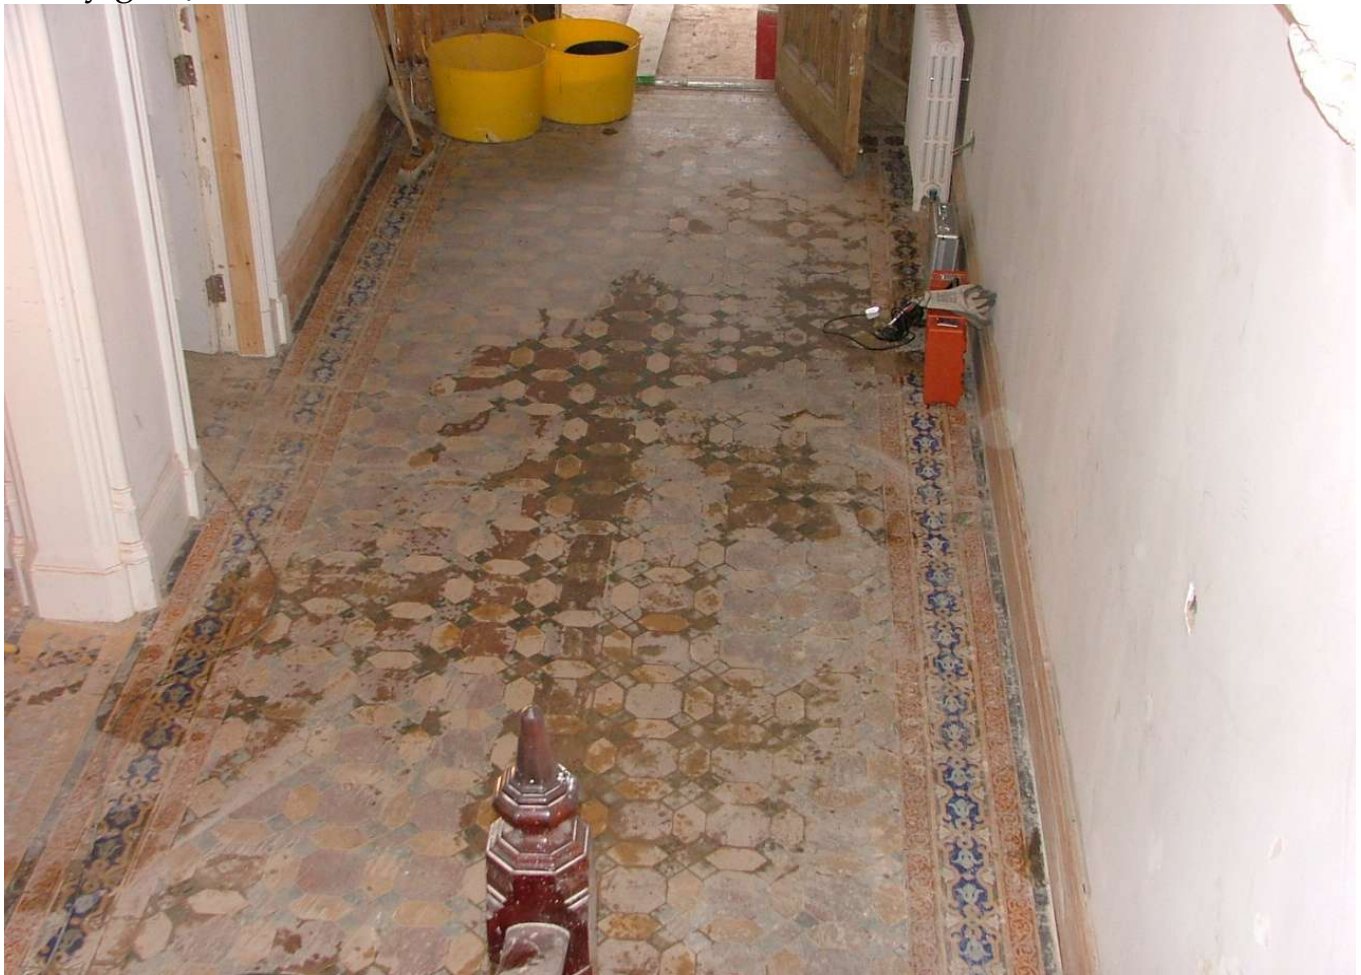
Bowden Mansion Victorian encaustic & geometric tiled floor prior to cleaning.

On a floor as old as a late Victorian encaustic & geometric tiled floor it is likely that the tiles will have had at the beginning a generous coating on a regular basis of linseed oil & turpentine oil (not the white spirit used today) this mixture causes the tiles to become sticky and attracts dirt, in the following decades the tiled floor will have had every type of sealer in vogue at the time liberally applied over the previous remnants which by the time our Co became involved these coating had made the tiling discoloured.

Above picture shows the floor after all the patches have been lifted & restored a few hours of cleaning now takes place starting with a mild alkaline cleaner, then a polish stripper followed by a PH neutral cleaner, plus use of a paint scraper for anything that resists the above.

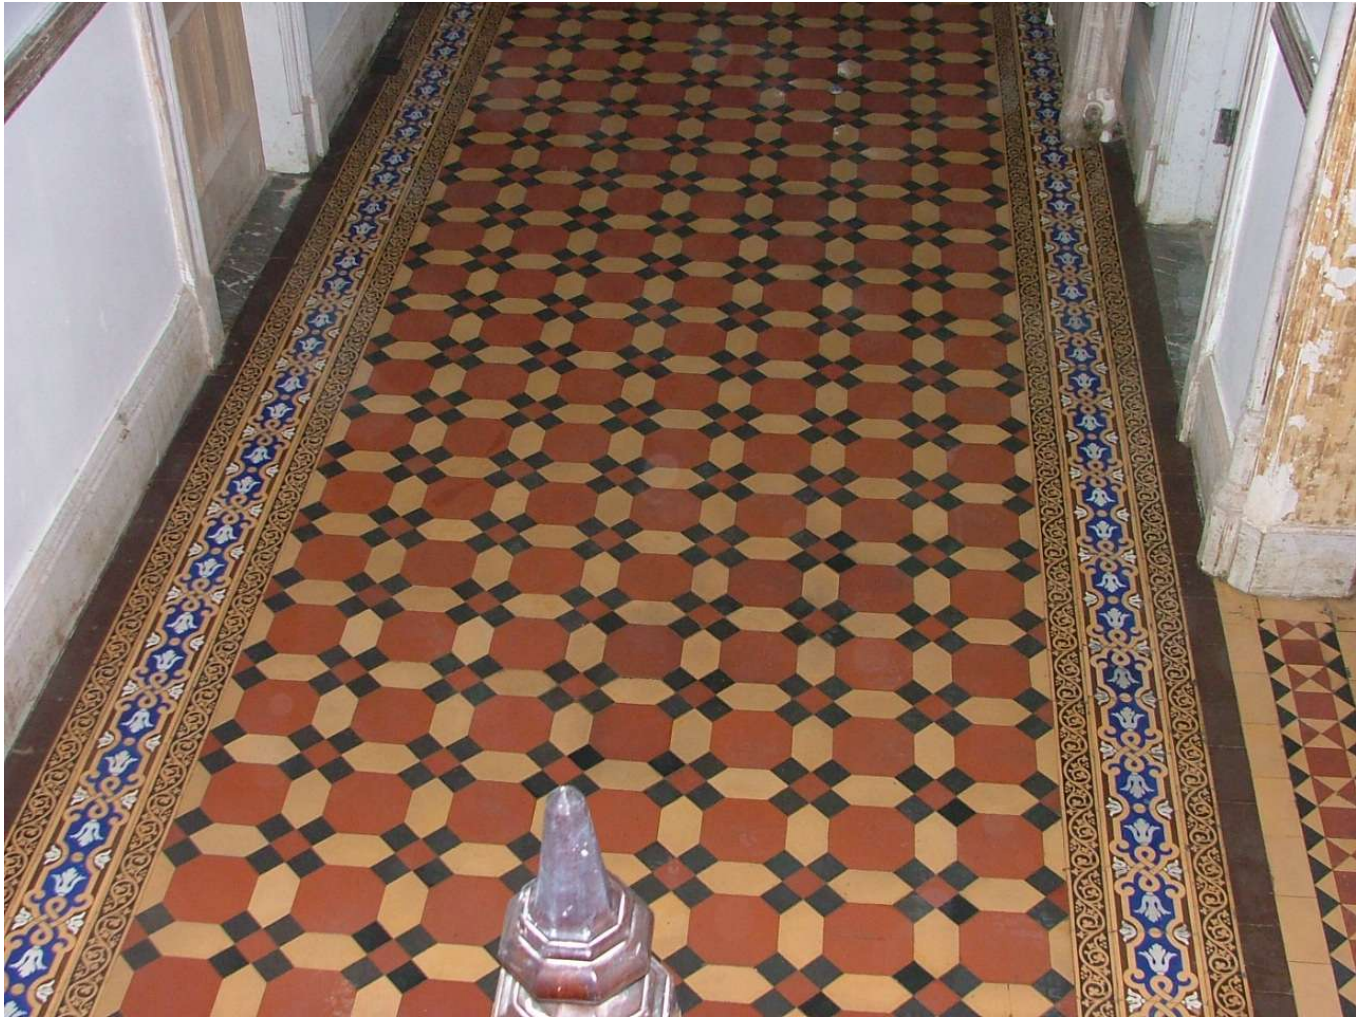
Bowden Mansion Victorian encaustic & geometric tiled floor restored.

Picture above shows the Victorian tiles restored after a month of hard work lifting tiles from the other hallway, which had more extensive damage than the one above. This hallway did have unusual thresholds = tiled in green marble!

As you can see below the intense deep cleaning provided by our Co brought out the vivid colours once more.

As the green marble thresholds were original they had to be retained, they were damaged and had sunk at angles. We lifted the pieces out glued them together and when they were sturdy enough they were re-fixed into the thresholds.

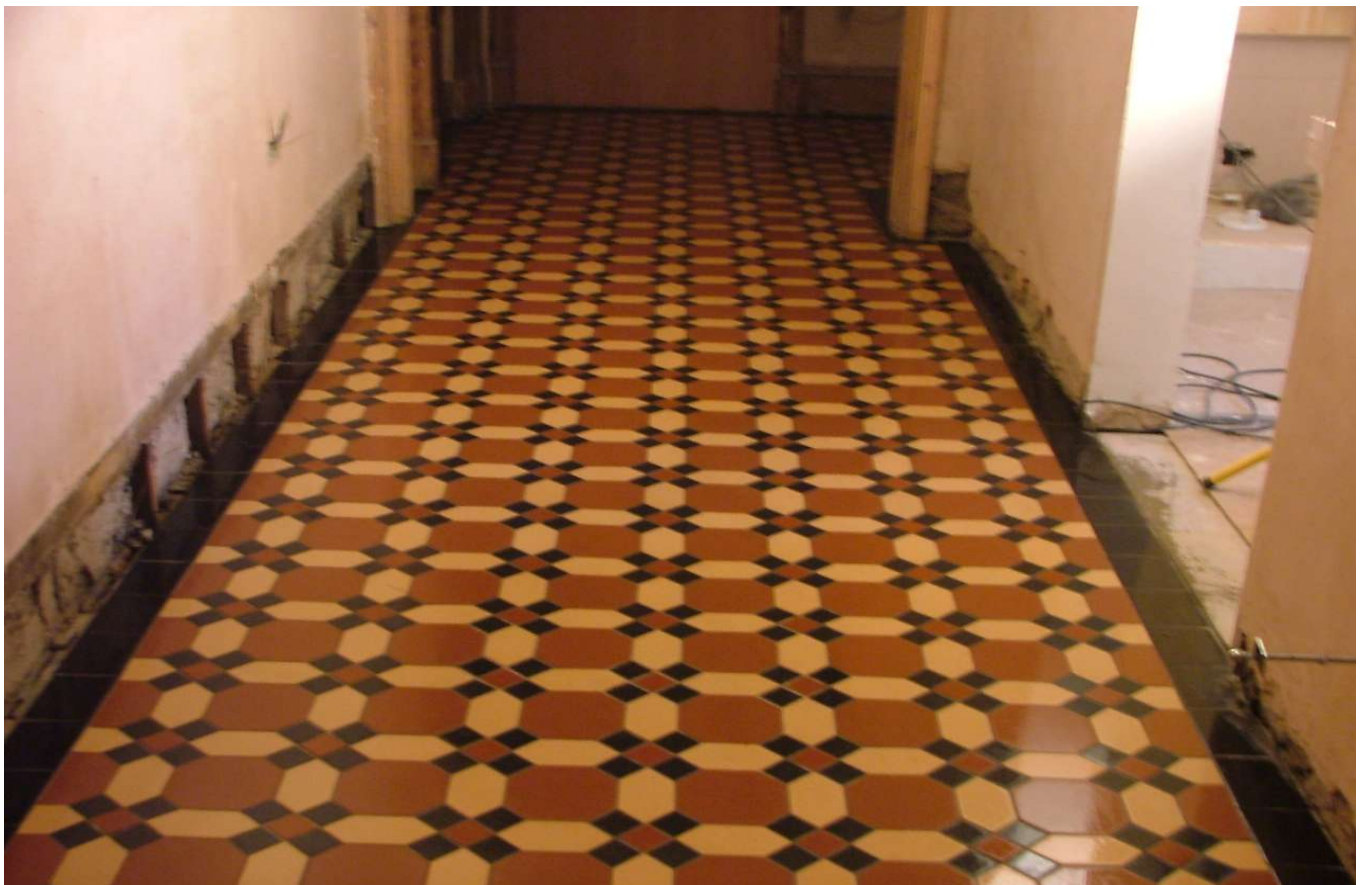
Bowden Mansion Victorian reproduction tiles by Craven Dunnill of Jackfield.

The above hallway had to have the old tiles lifted plus areas of mortar and in-fill areas of a red terrazzo!

Below pictures of the new sections tiled with Victorian reproduction square edged tiles by Craven Dunnill tiles of Jackfield. Thankfully commonsense prevailed and the tiles did not have to be made in the six & half inch format of the original Godwin tiles. Apart from the lack of an encaustic tile border (client would not pay out) these tiles by Craven are a very good match to the original Victorian tiles. The hallway was very damaged and had large areas of just mortar in-fill, the recovered tiles were used to restore the original tiling and our Co re-screeded this hallway to accept the new tiles.

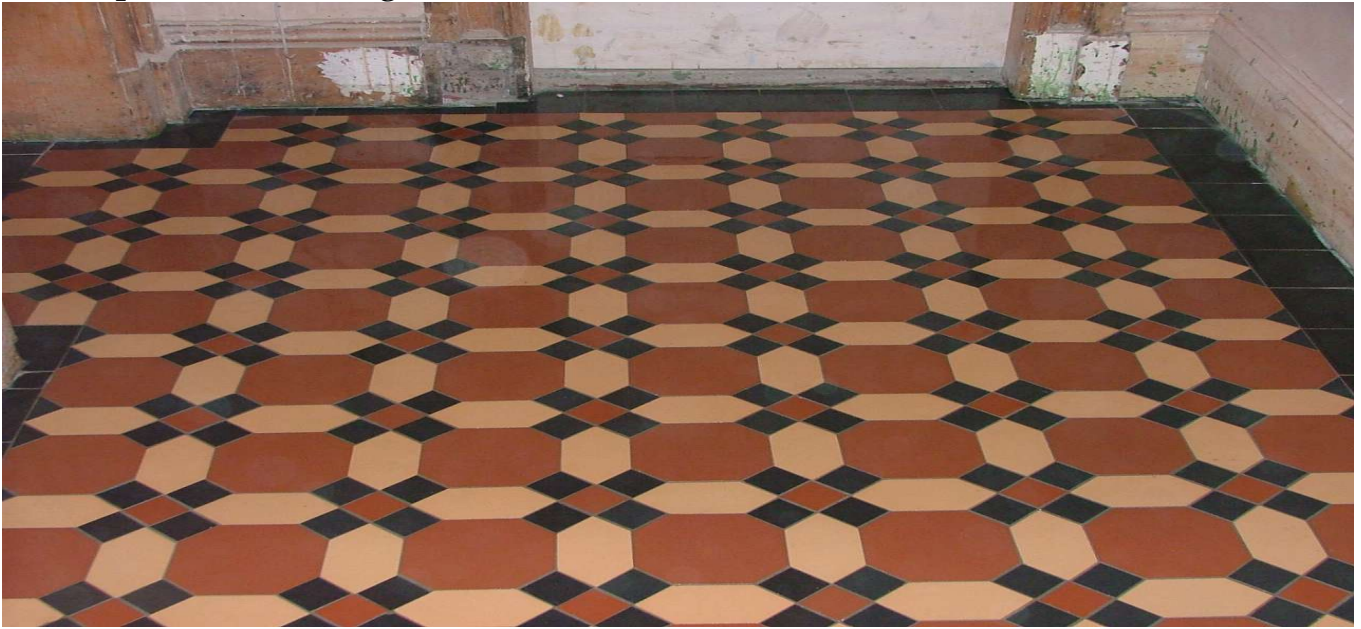
Continuation of new Victorian reproduction geometric tiled floor.
