Victorian Geometric tiled floor restoration project. Bristol un-listed.

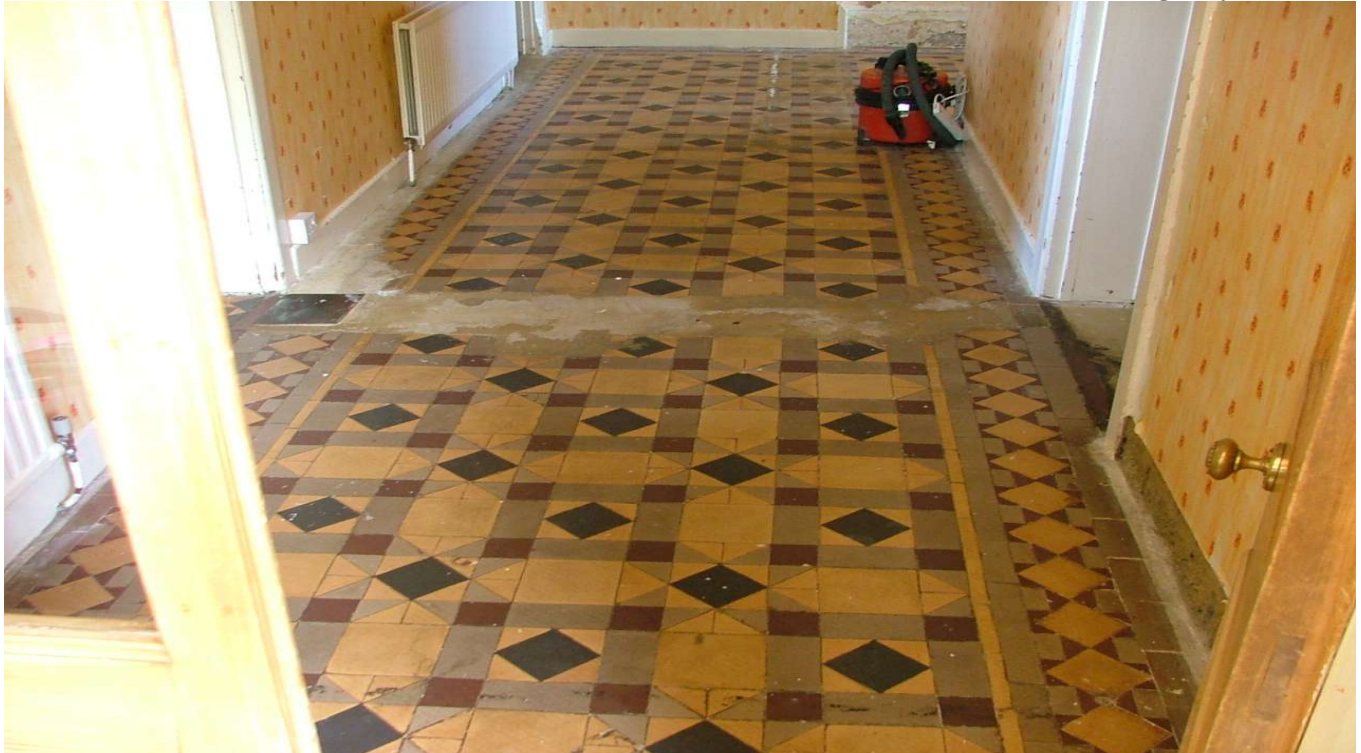
Mortar infill mid pic.

Fore-ground shows broken and discoloured tiles. Infill was removed using Exakt Saws in tandem fitted with diamond blades to cut down the edges of the infill allowing for the mortar in-fill to be removed with mini-crow bars and a hammer & chisel as the mortar was now separate from the tiled floor due to the depth of cut it meant that the in-fill could be removed without causing problems.

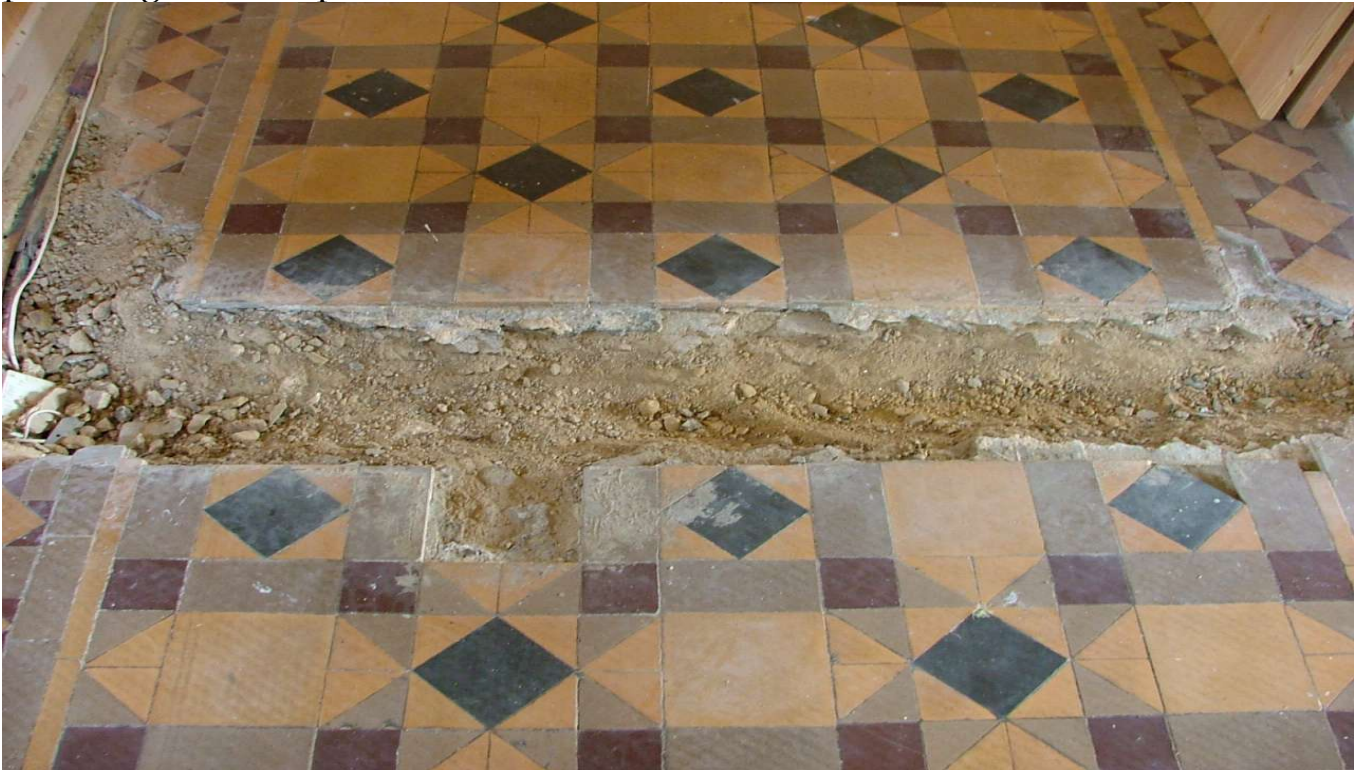
Main infill dug out prior to re-screeding.

The loose rubble & dust will be removed by brushing & pan & handpicking the larger pieces and finally will be hoovered.

Next a sheet of heavy duty plastic will be cut to fit and used as a DPM (damp proof membrane)

The trench will then be filled to a point below the existing tiles with semi-dry fibre enriched sand & cement.

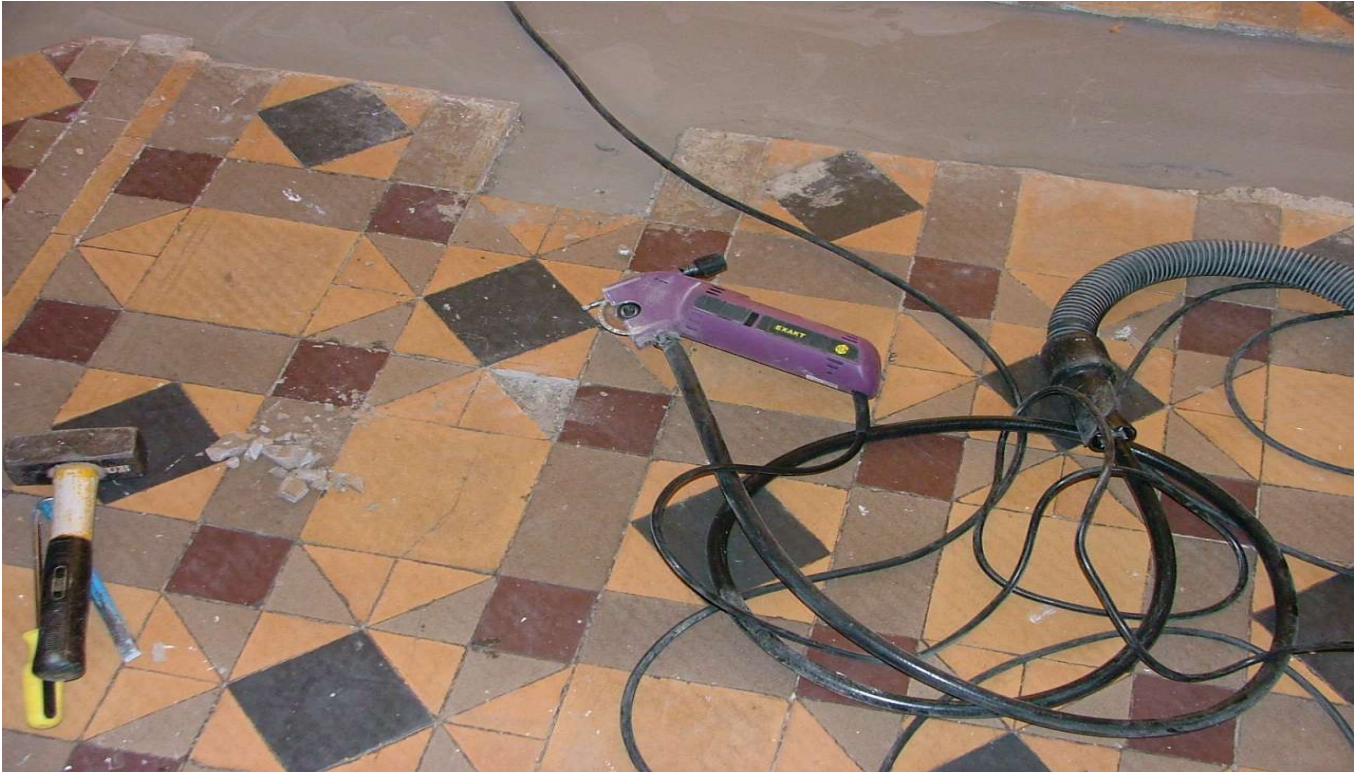
Trench filled & levelled.

Leveller was Kerakoll R10 adhesive used was H40 eco flex and grout cement

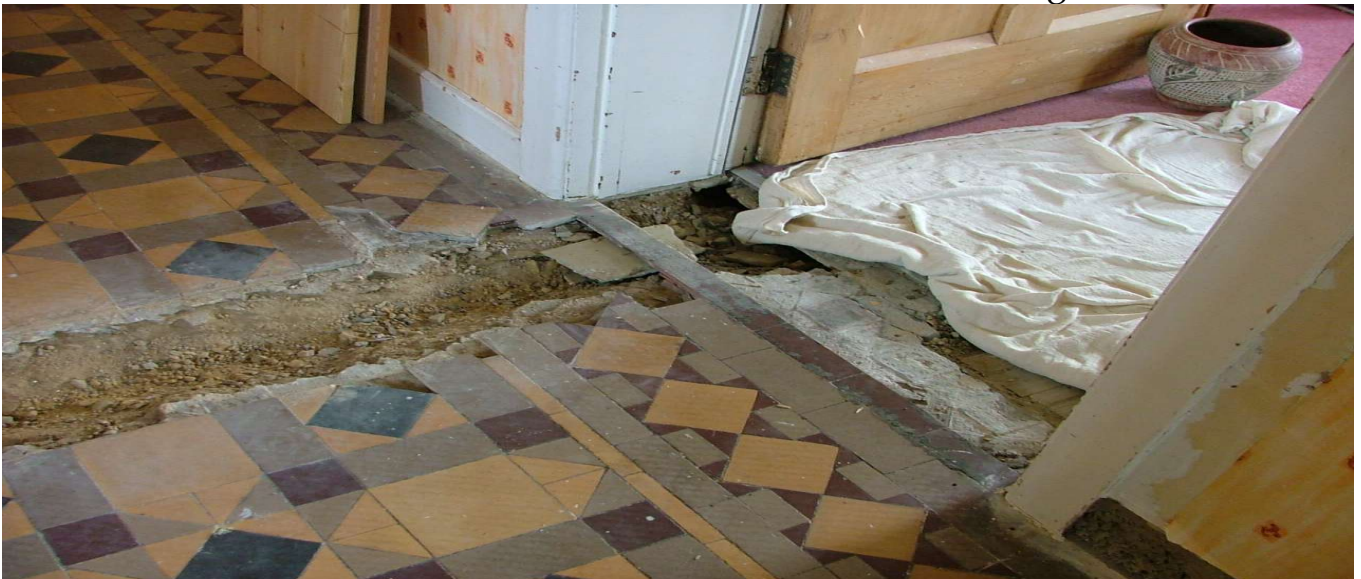
In-fill removed showing threshold.

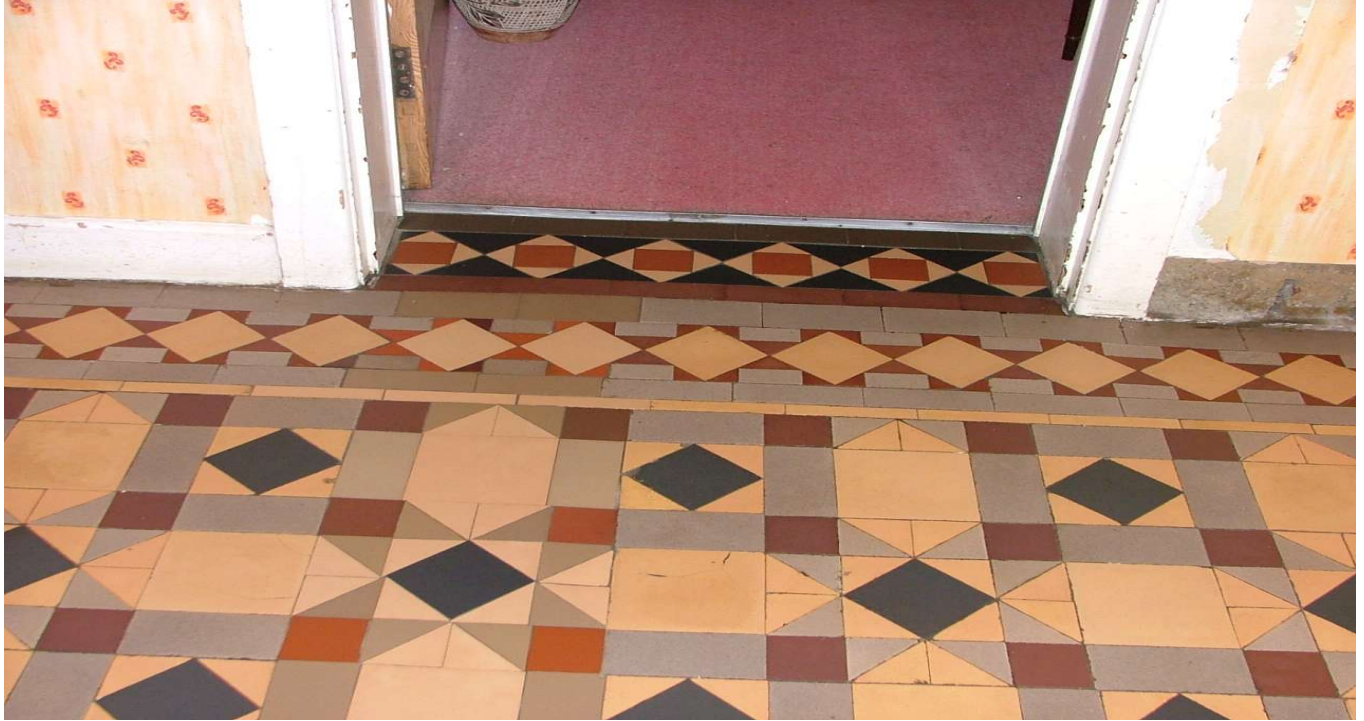
Threshold & end of run restored.

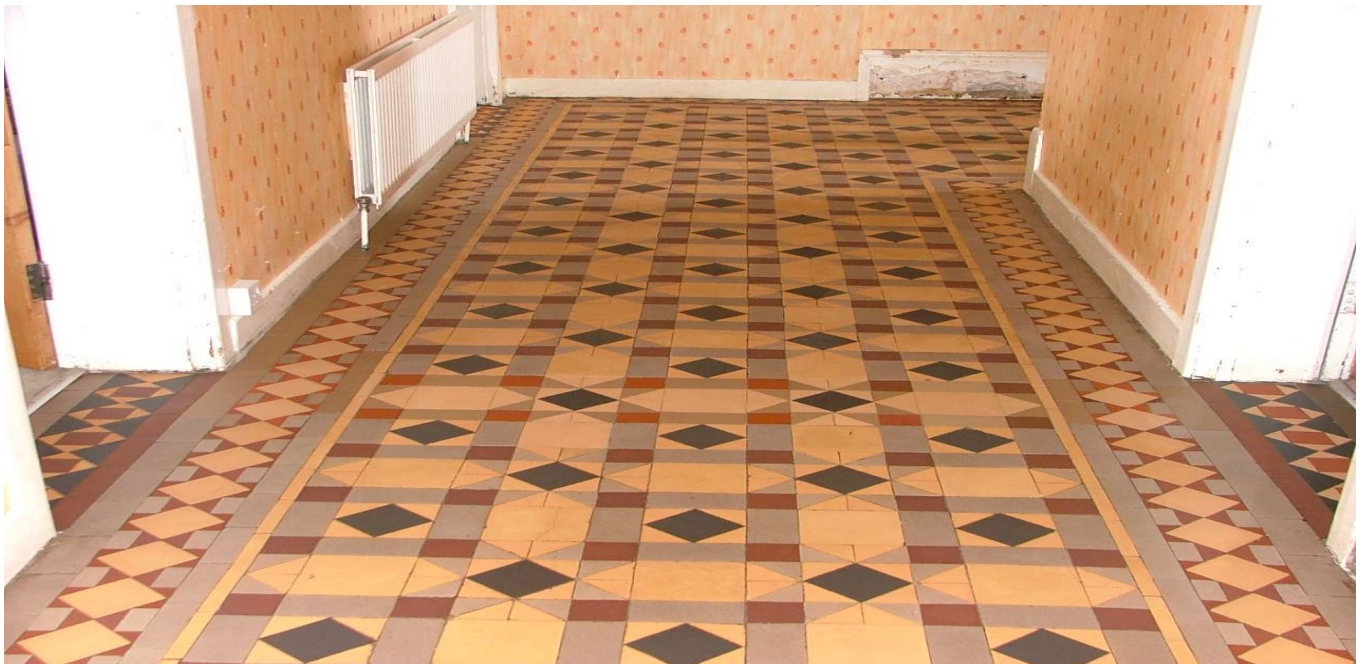
Main floor restored-cleaned & sealed. Dry-Treat was sealer used. Tiles used to restore this floor were a mix from our re-claimed stock & Craven Dunnill tiles of Jackfield.

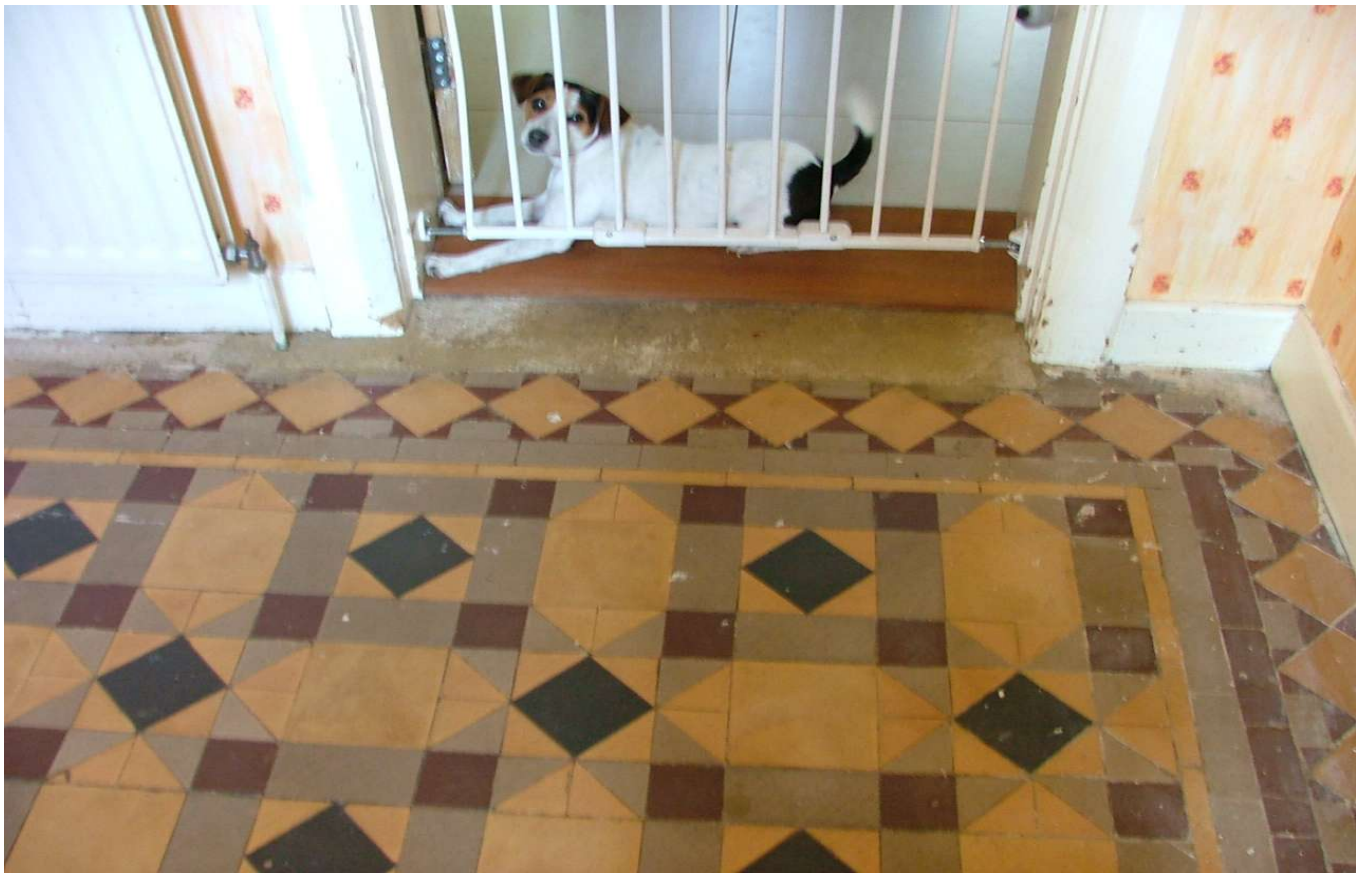
Ramp threshold badly screeded repair over lineal run of pipes.

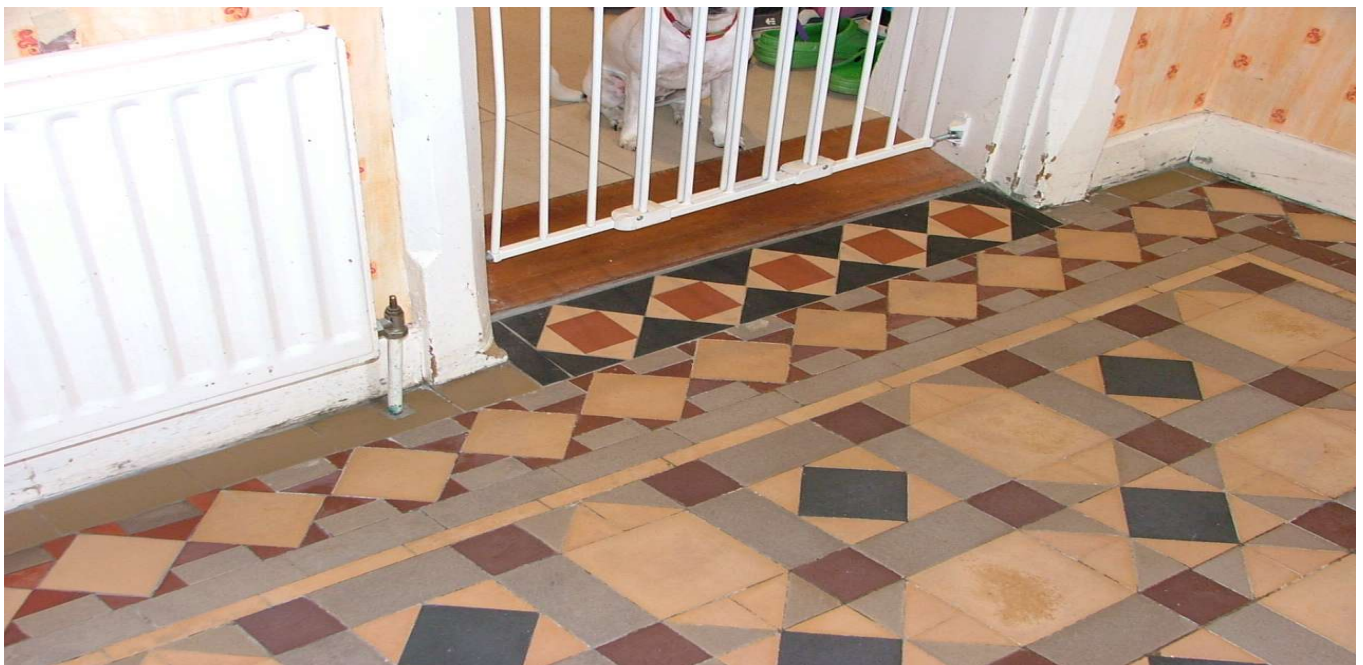
Ramp threshold after restoration.
