Kirton -In - Lindsey Town Hall.

Restoration of a Grade 2 listed building Victorian Geometric tiled floor.

This contract was too restore an original late 18th century Victorian Geometric tiled floor and to add an extension floor that complemented the original tiling but did not slavishly copy the original design.

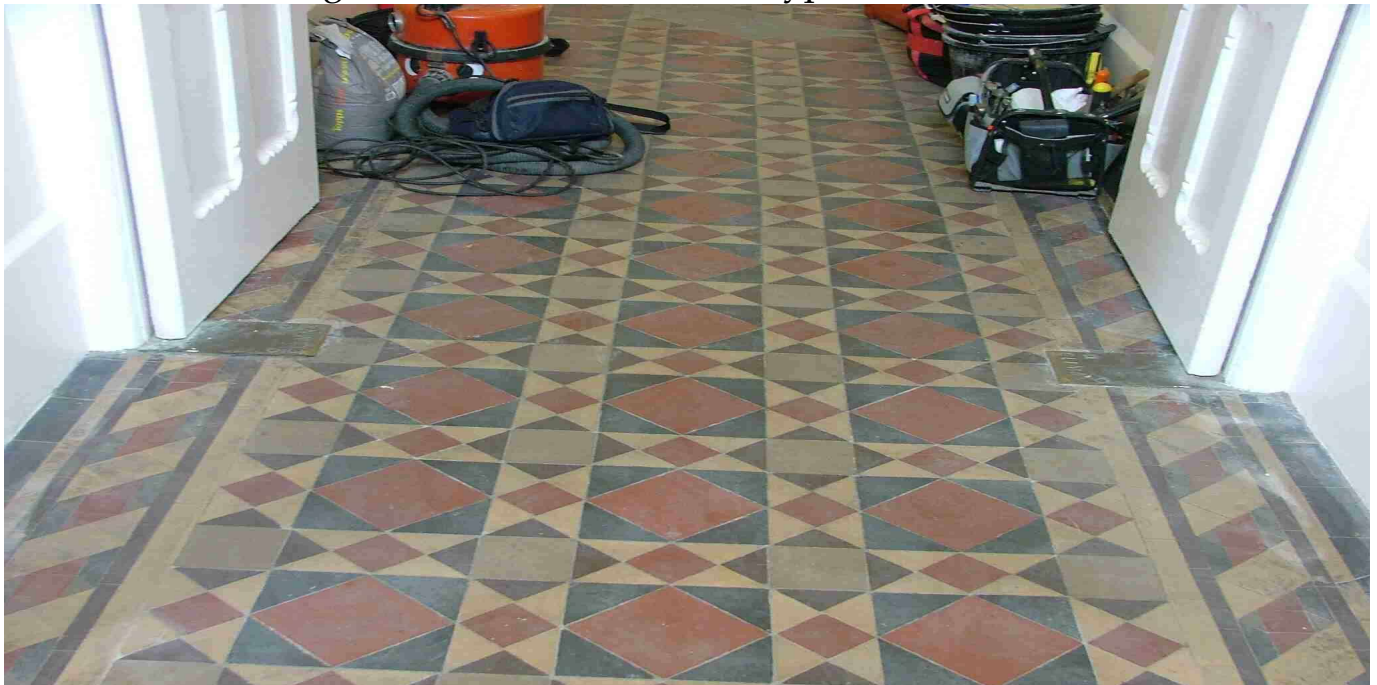
The original floor had lost a few patches of tiles which had been in-filled with almost neat cement mortar.

The tiled floor had also been covered a few times in a dwell-on sealer usually water-based although there are traces of other types of sealer.

Kirton TH floor before restoration.

Victorian tiled floors are very porous and as a result look good whilst wet and when they dry the above look is typical= drab and almost dusty looking.

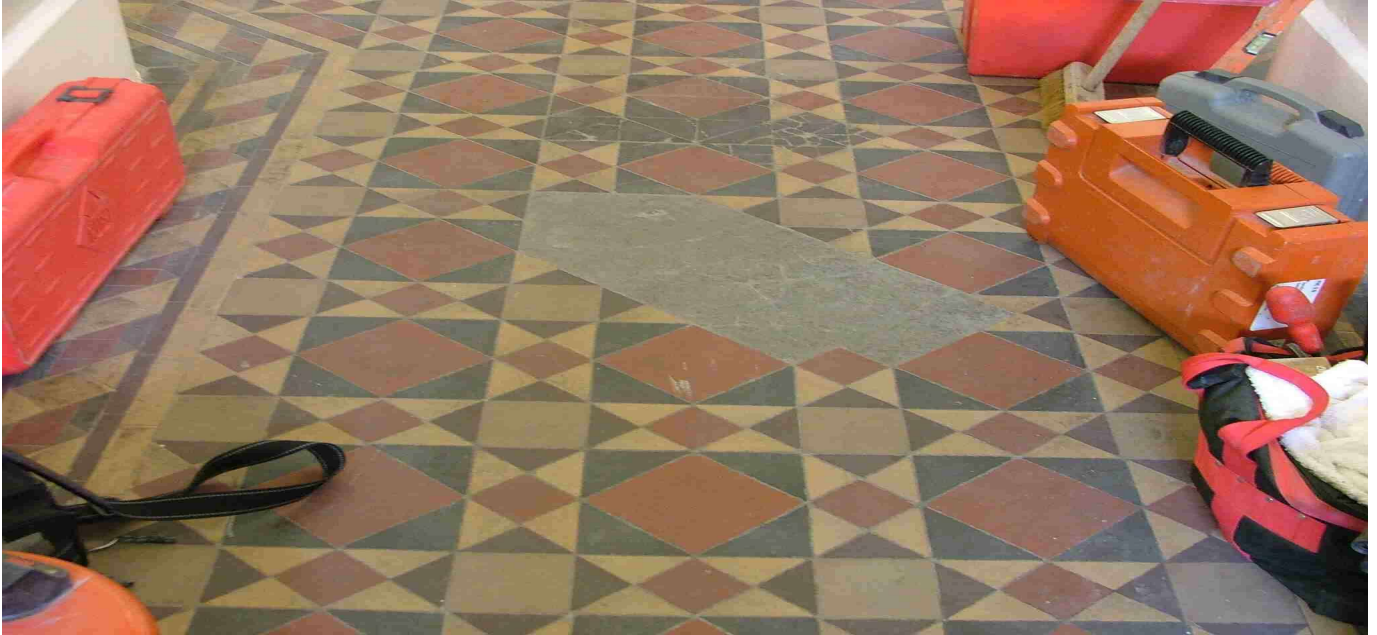
Cement mortar patches.

The damaged tiles & patches are removed using an Exakt saw to first cut around the tile or the perimeter of the patch, this de-couples that tile or patch from the main floor and the cut extends into the screed below, this prevents any disturbance or percussive damage from either a hammer & chisel or other tools being transmitted to the main body of tile.

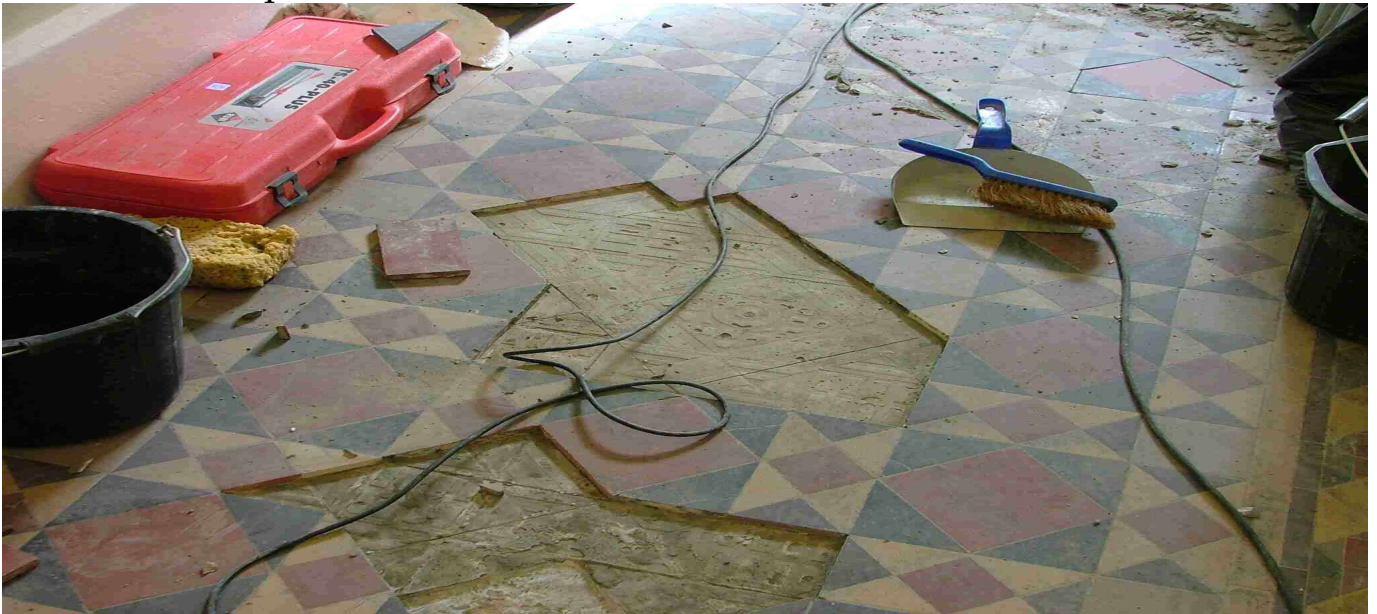
Cut out patches using an Exakt saw fitted with diamond blades.

The screed is now ground down with a Fein Supercut tool with rasp attachments and possibly using an Arbortech power chisel for fiddly areas where use of a hammer & chisel might cause the adjoining tiles to lift.

Once the underlying screed has been removed to a depth to allow a bed of adhesive and a replacement tiles then tiles will be cut from re-claimed tiles or a new close match tile.

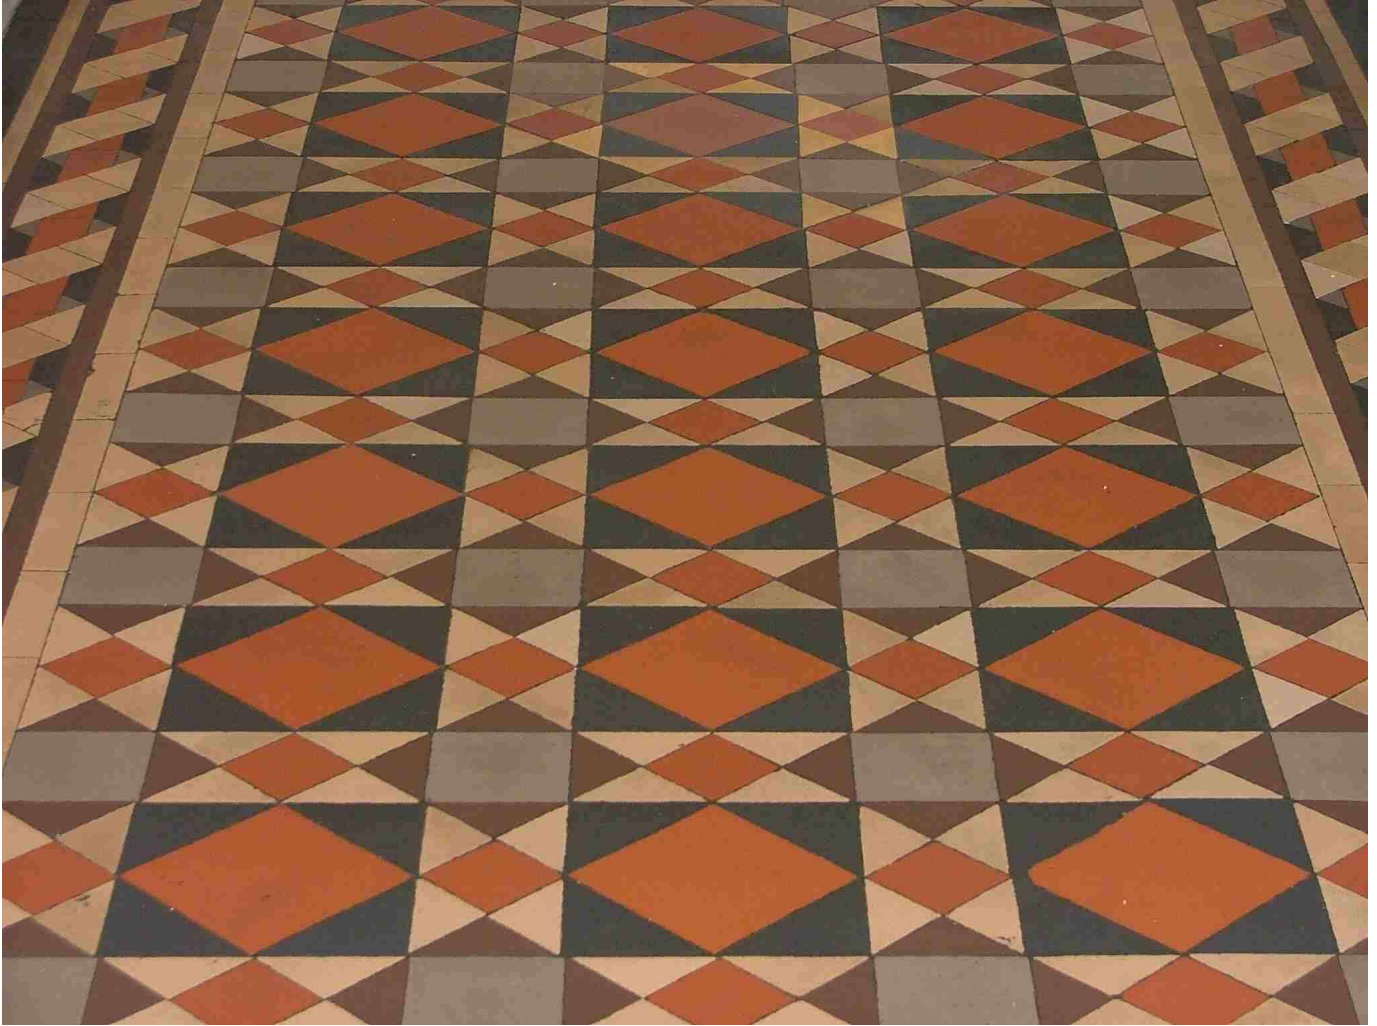
Patches re-tiled & grouted.

There were small sections like this all over the main floor I used both original re-claimed tiles and new repro tiles that matched as close as possible.

These tiles will be beaten into place using an oak board & rubber mallet.

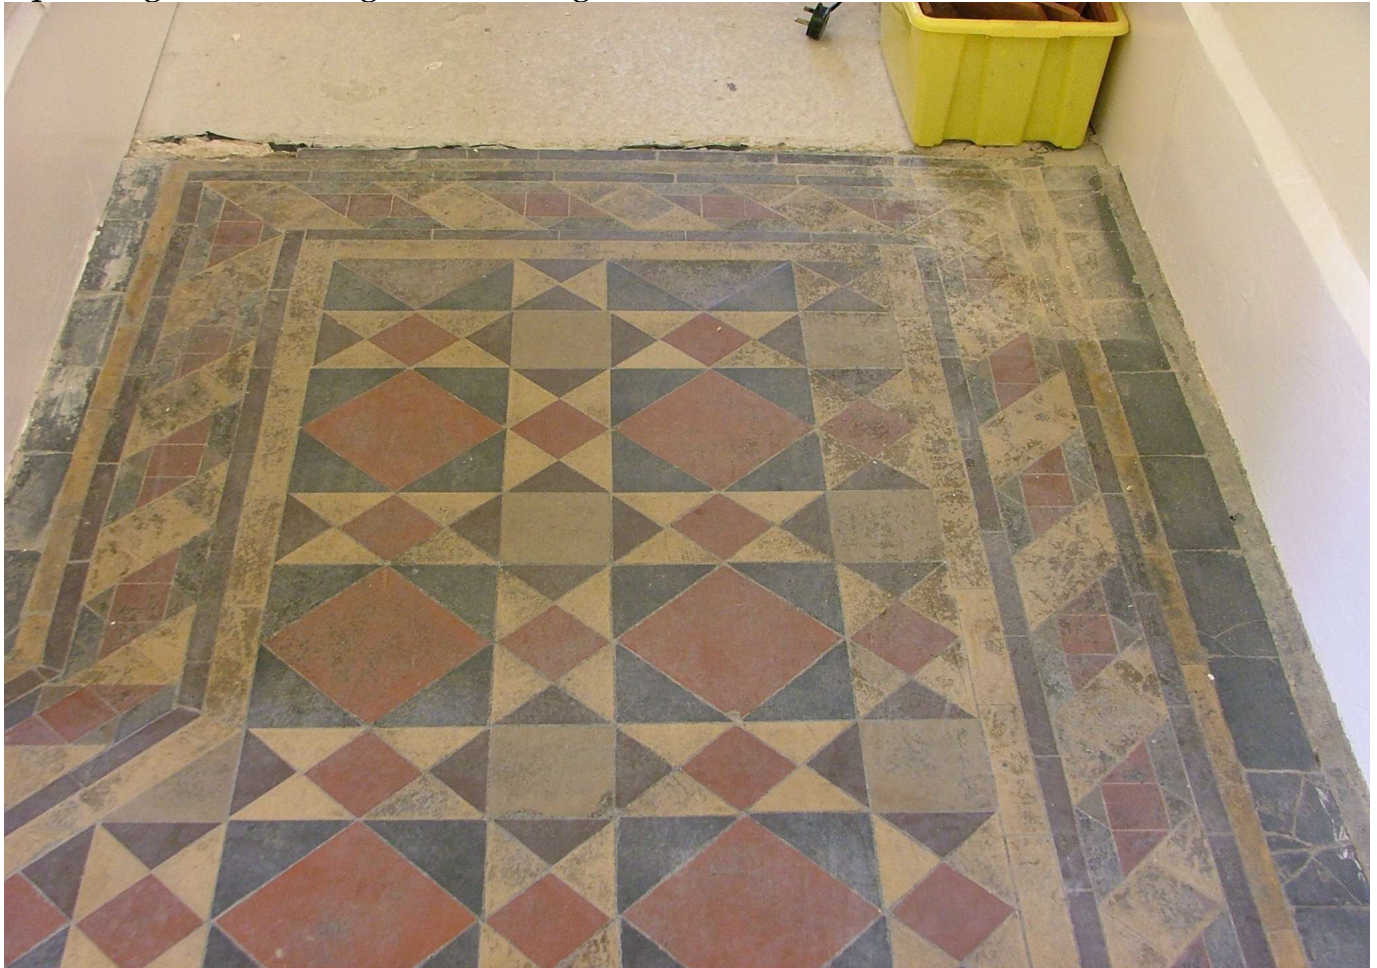
End of Original tiles, top of picture show's new un-tiled section.

The edge of the original tiles are tidied up using a Fein Supercut with diamond blade attachment, this is so the new tiles can be butted up.

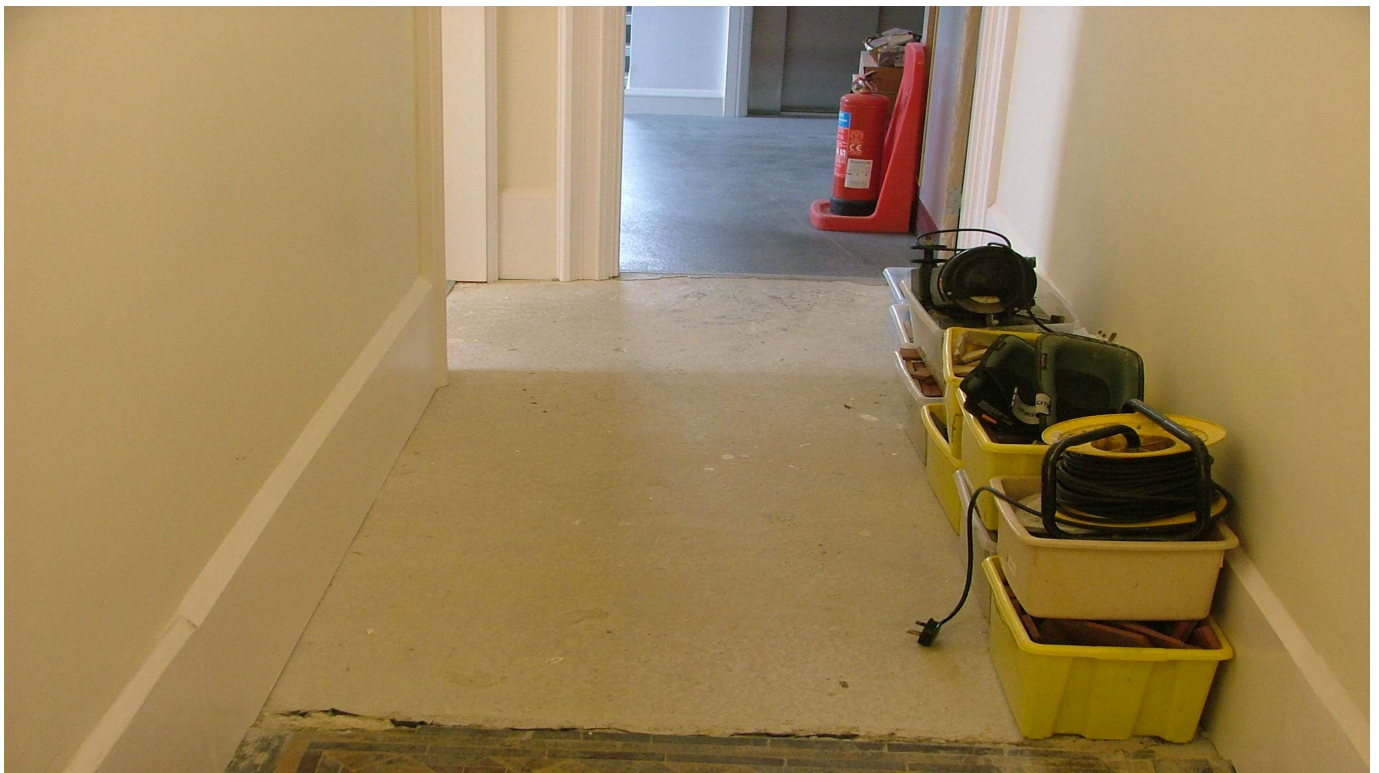
New section ready for levelling prior to tiling.

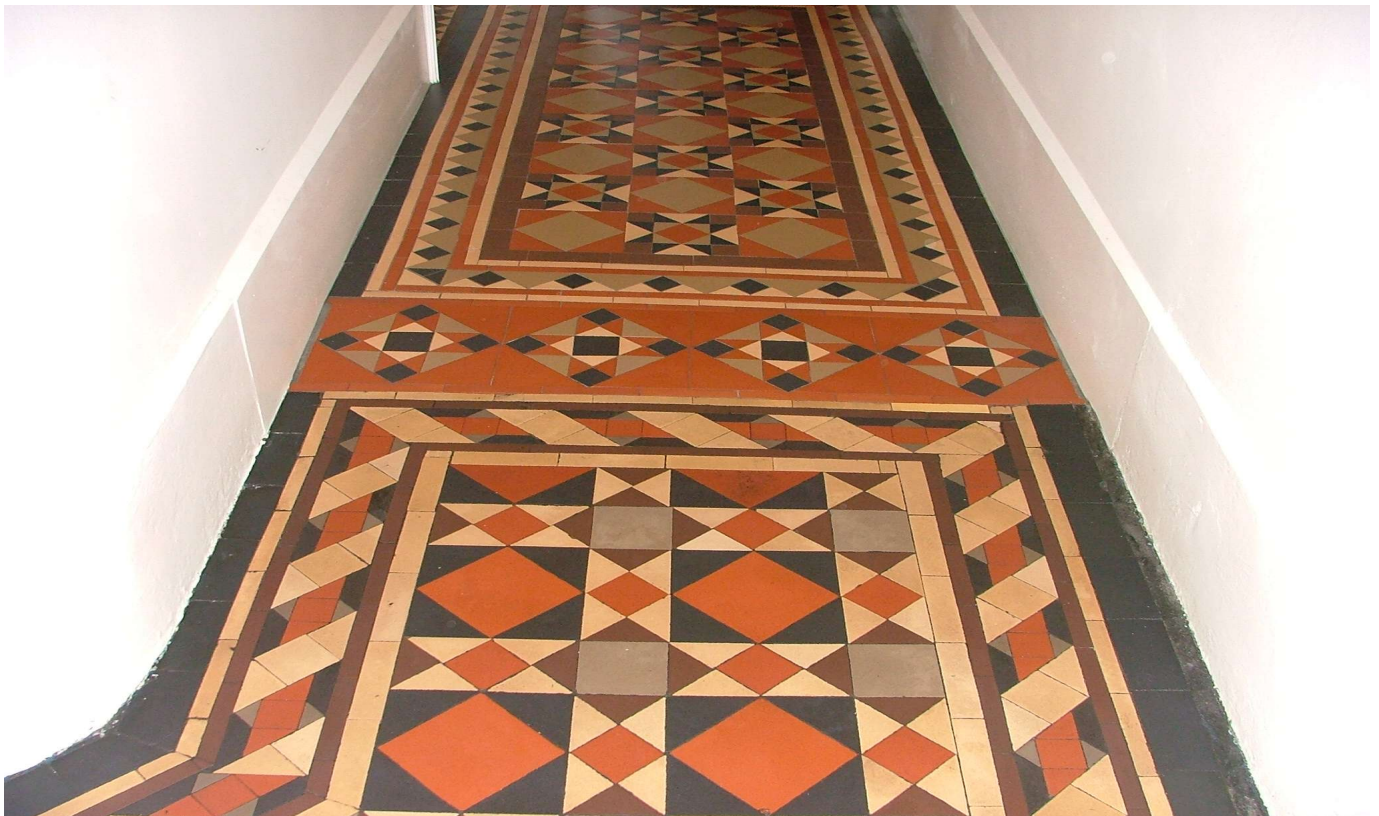
New bridging section of tiles and part of the new extension tiling.

I decided to use a technique I have used before and that is to put a bridging threshold in. this is a new section of tile which complements both the old floor and the new section of floor and has elements of both in design & colour.

It also helps in re-setting the new floor as usually the new extension will not be square against the original building as in this case.

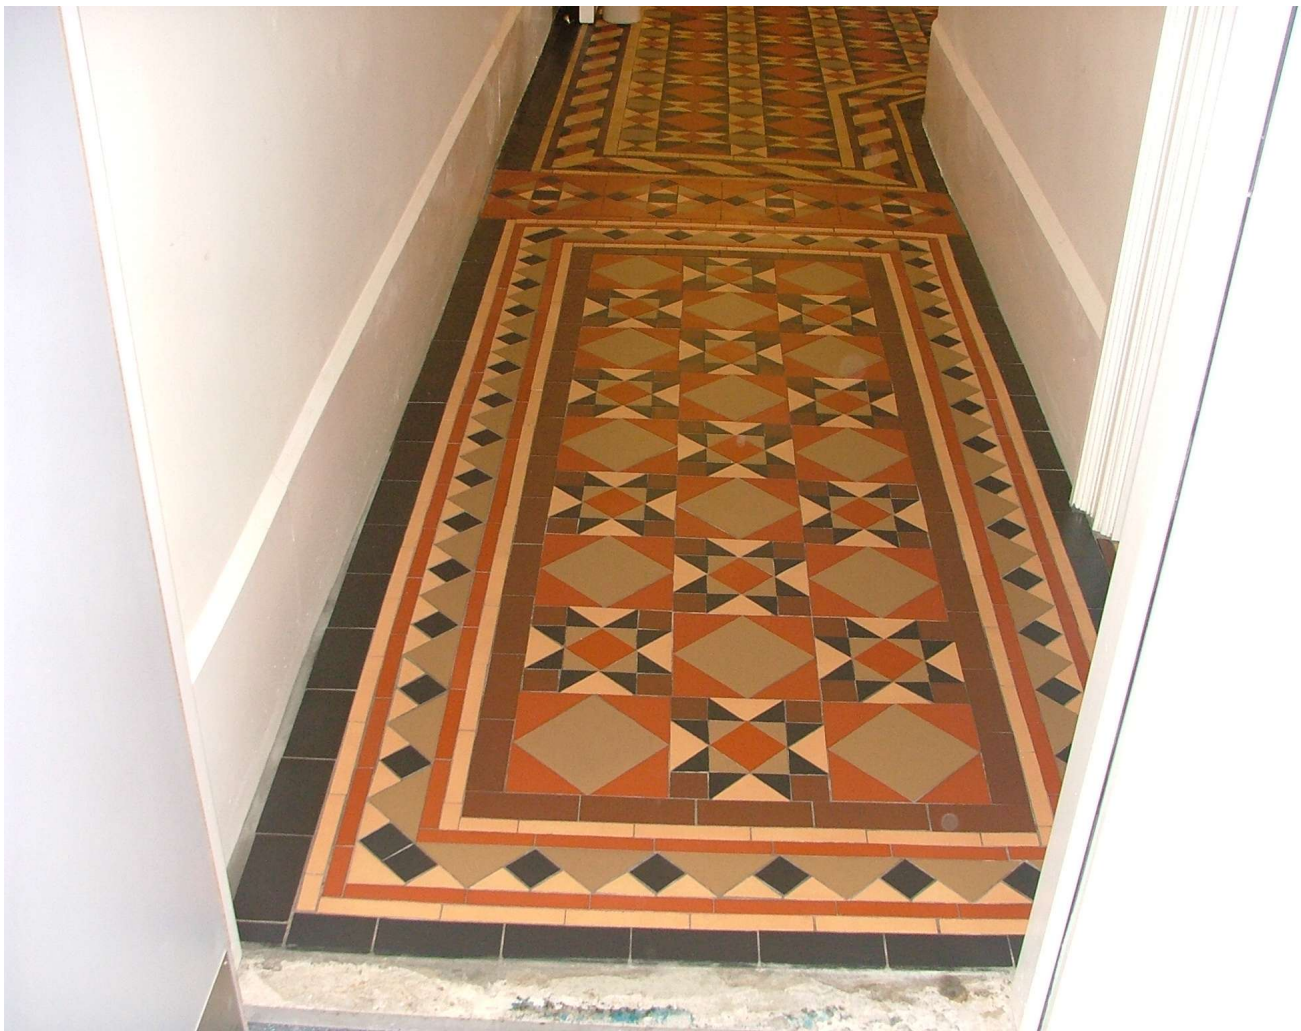
New tiled section.

This new section uses the same colour-way but in a different set out use of an internal variable so that the pattern followed the same main field as the original was necessary that is the 6x2 inch brown tile strip on the inside of the border tiles before the main tiled pattern starts.

This is a way of setting the width of the main field pattern so that symmetry is attained.

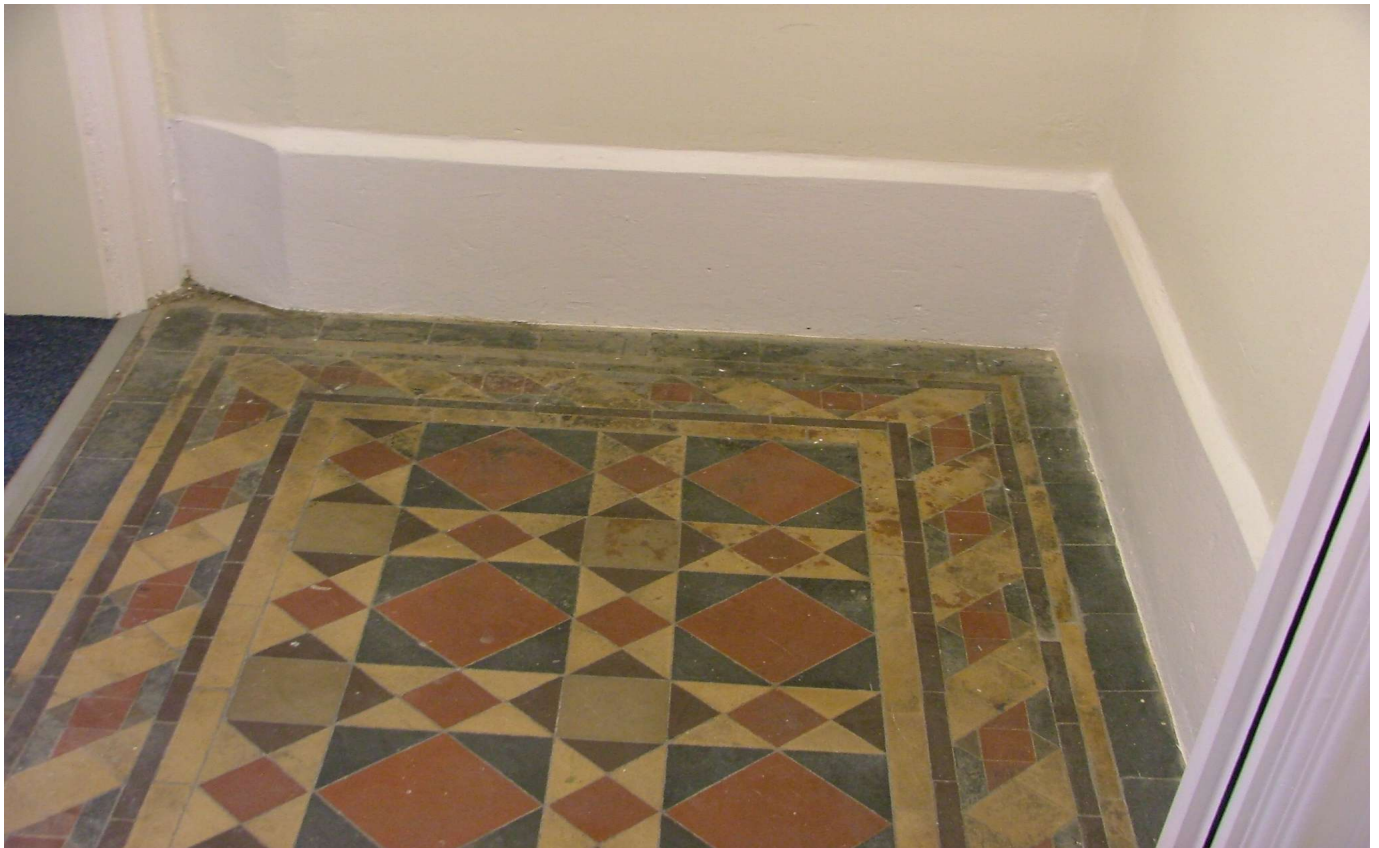
Original floor section showing how grubby it had become with dirt and sealer build-up

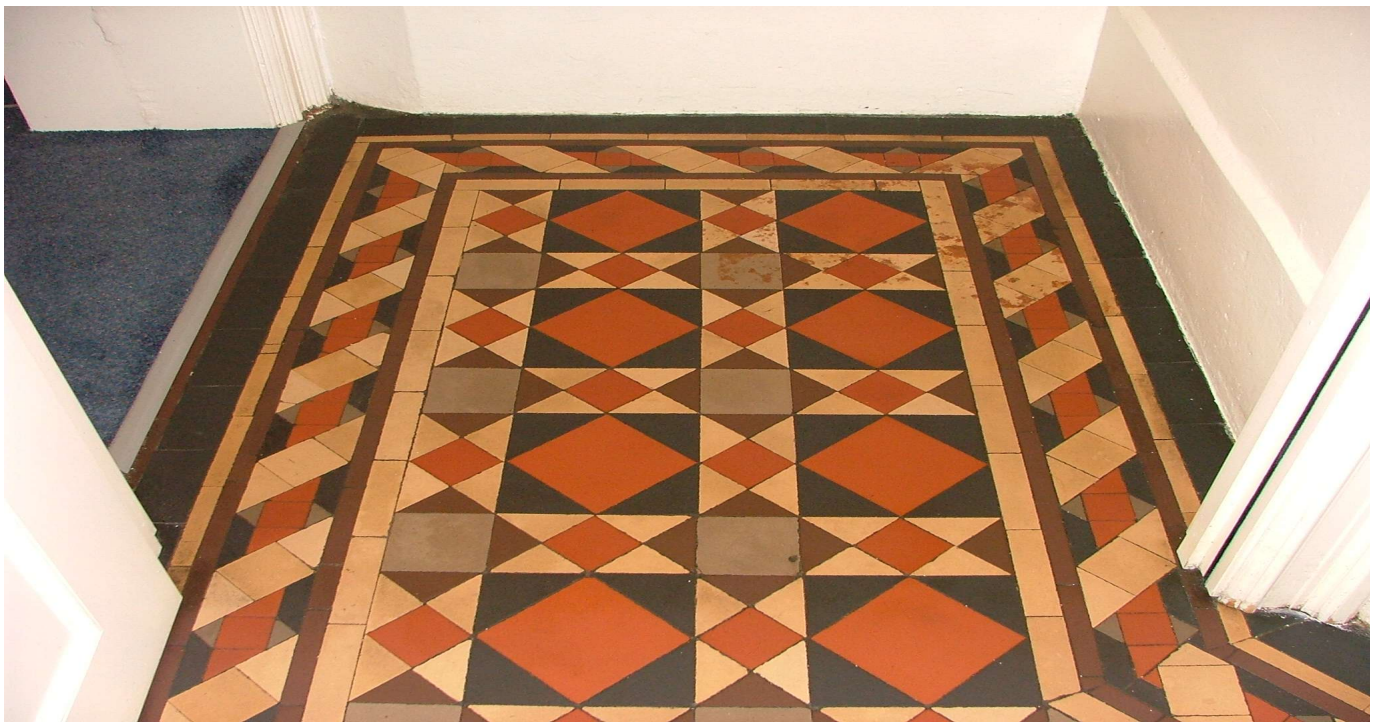
Same end section with dirt removed- slight rusting stains which can be common on floors laid over dirt.

The floor is cleaned with a low rpm scrubber approx 200 rpm this ensures the tiles get cleaned but at a rate that is safe, a high speed heavy cleaner could dislodge some of the tiles.

A mild alkaline cleaner is used first neat rather than diluted as this type of floor will be ingrained with the dirt of 100 years + it is pointless to be too gentle with dirt that long established.

A polish stripper neat is used next, then the floor is allowed to dry for approx an hour (natural lunch break) the original floor was then checked for paint splashes and any other stains like varnish seal etc.

These are removed manually with a long handled paint scraper with a sharp razor type blade at the business end.

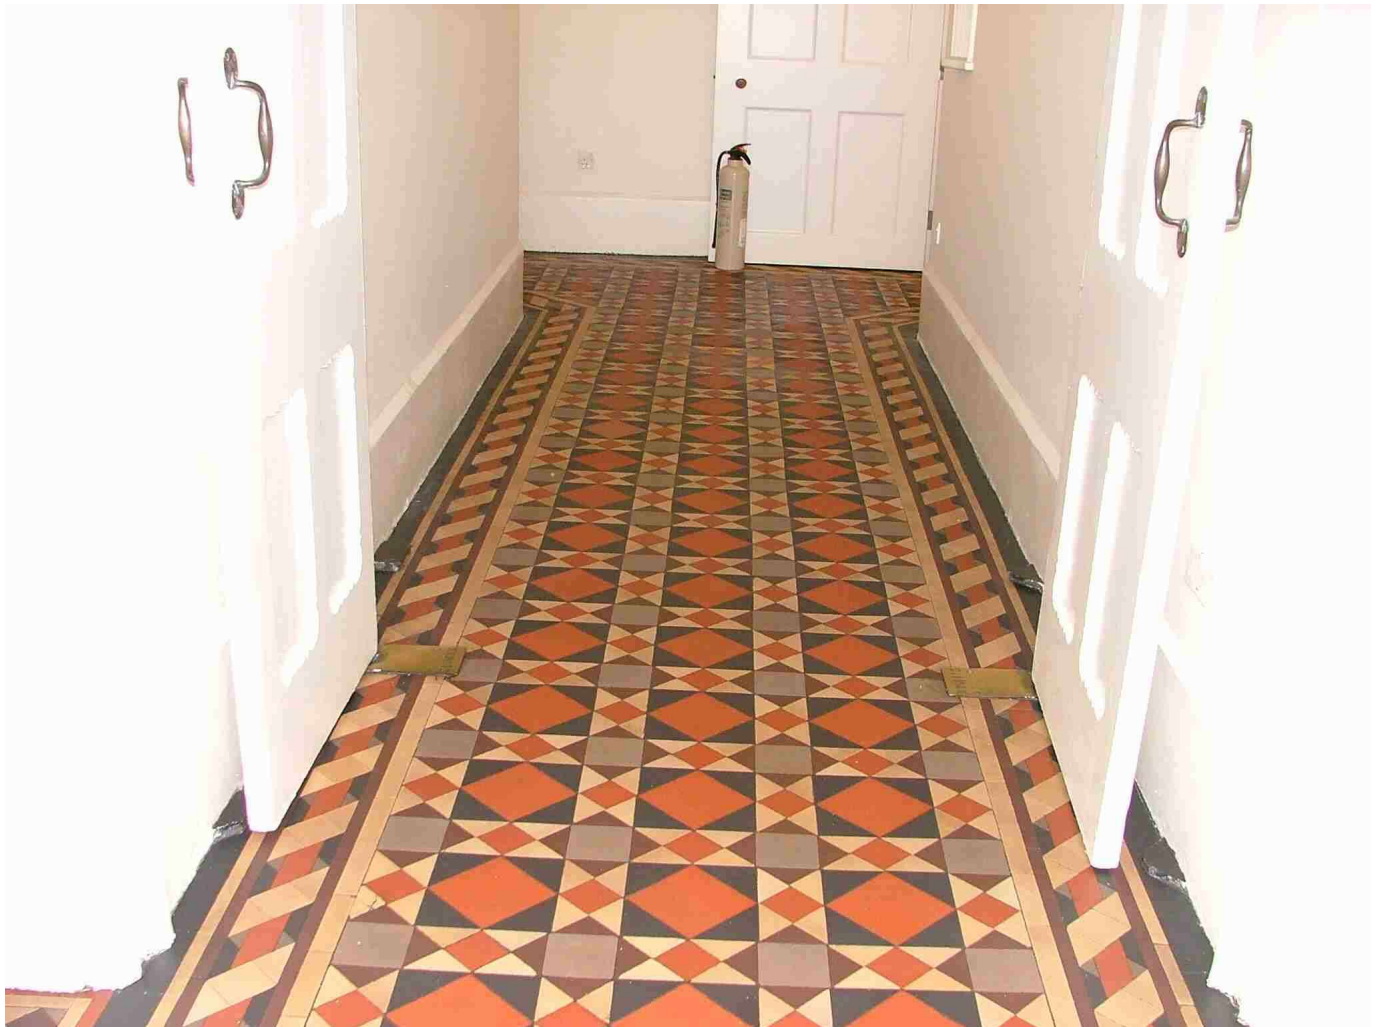
Main floor cleaned & sealed.

The floor is now sealed and our Co now favours only one sealer and that is Dry-Treat stain proof this sealer is virtually client proof. The sealer allows air in & out so the floor can breathe which is very important with lime based screeded floors which accounts for approx 98% of all Victorian tiled floors.

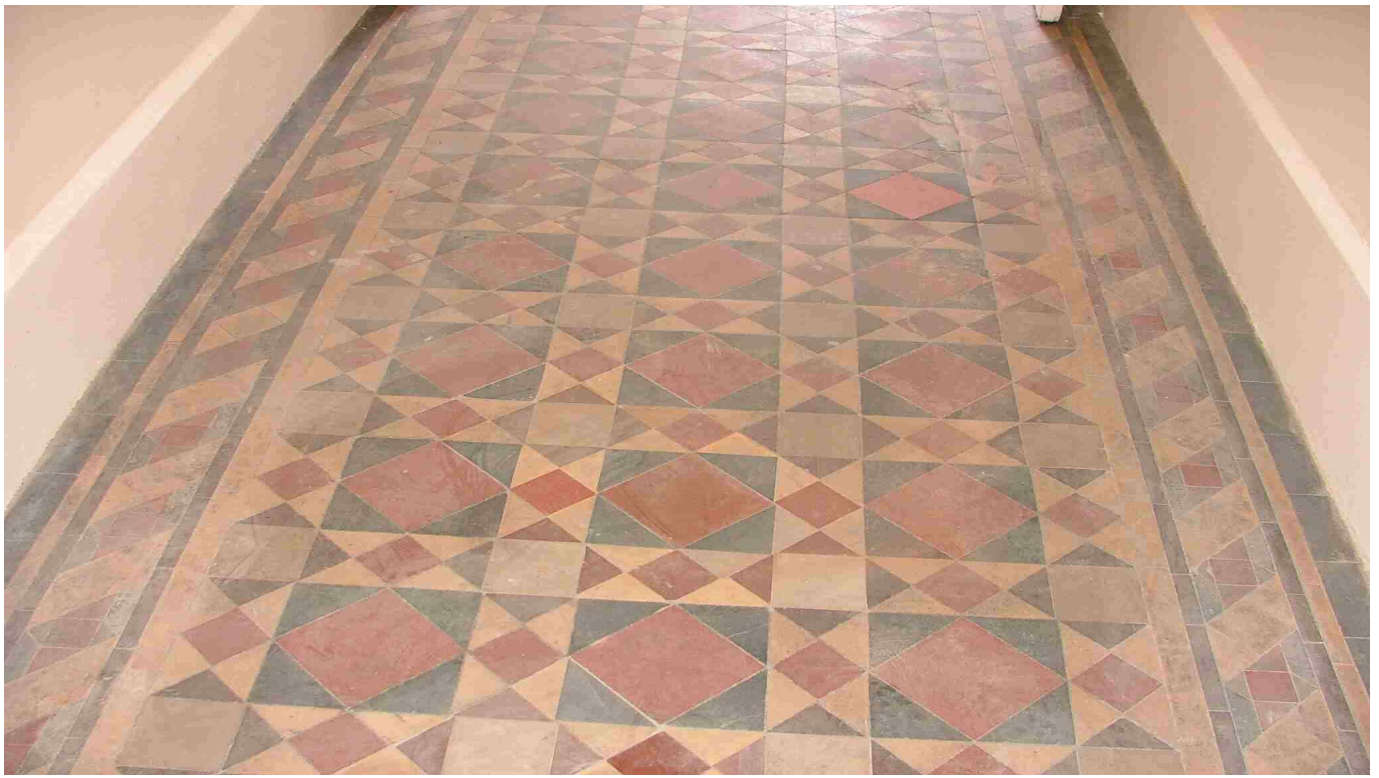
Main floor un-cleaned or sealed.

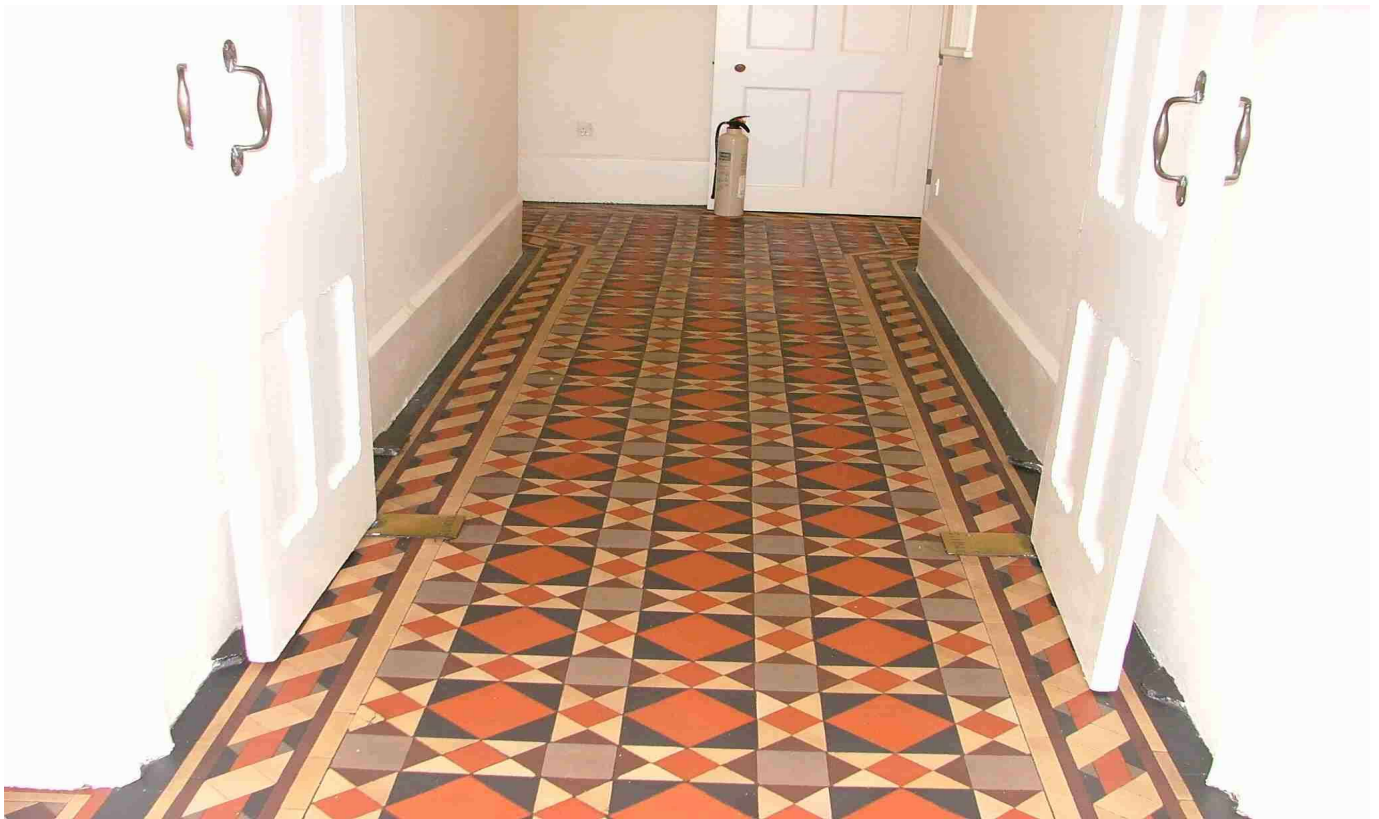
Main floor cleaned & sealed.
