Gwernaffield Church N. Wales, Victorian encaustic & geometric tile restoration.

The Grade 2 listed Church was originally built Circa 1760 it burnt down in a fire around 1790 and was rebuilt in the early 1800's, the church floor tiles were put down as & when the church had enough funds as the tiles are from different time periods.

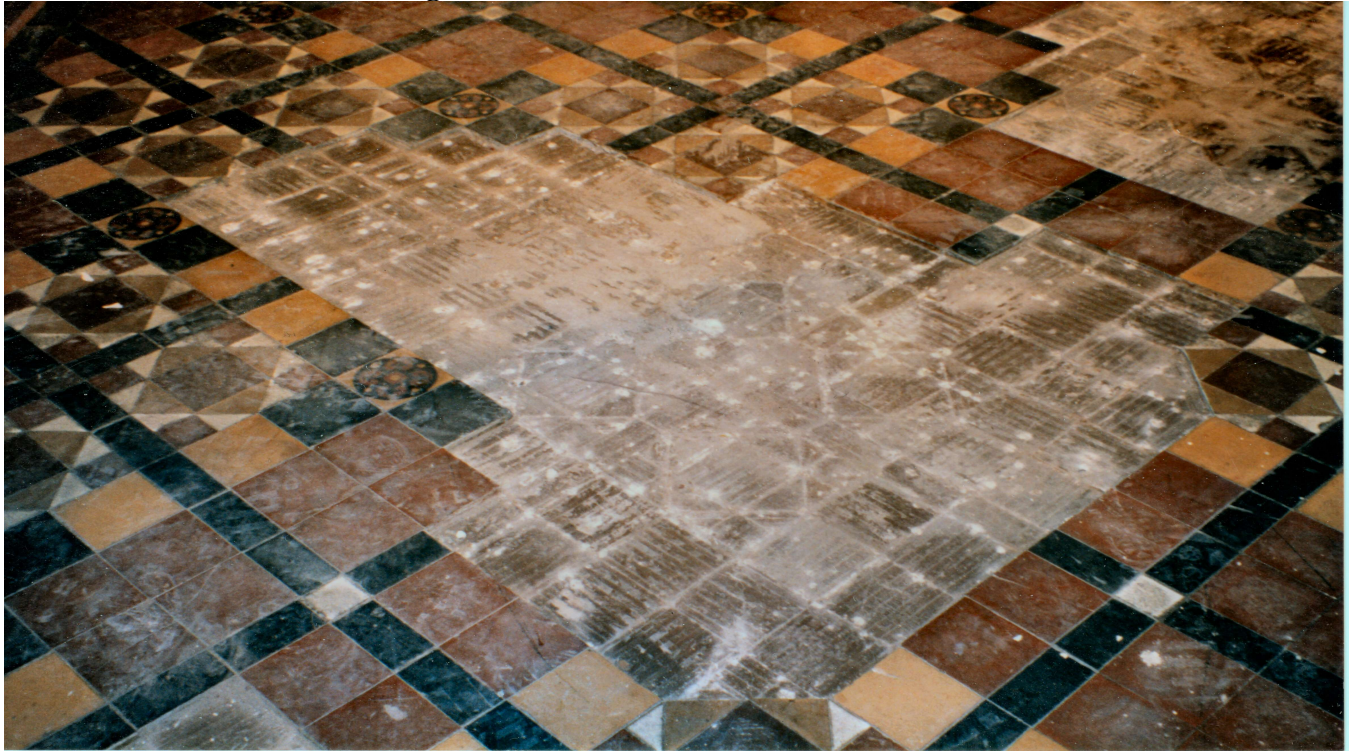
The tiled floors had suffered water damage from a leaking roof.

Also a new heating system had dried out the floor to such an extent that the screed had shrunk causing the tiles to buckle or heave.

Victorian encaustic & geometric tiled floor showing water damage.

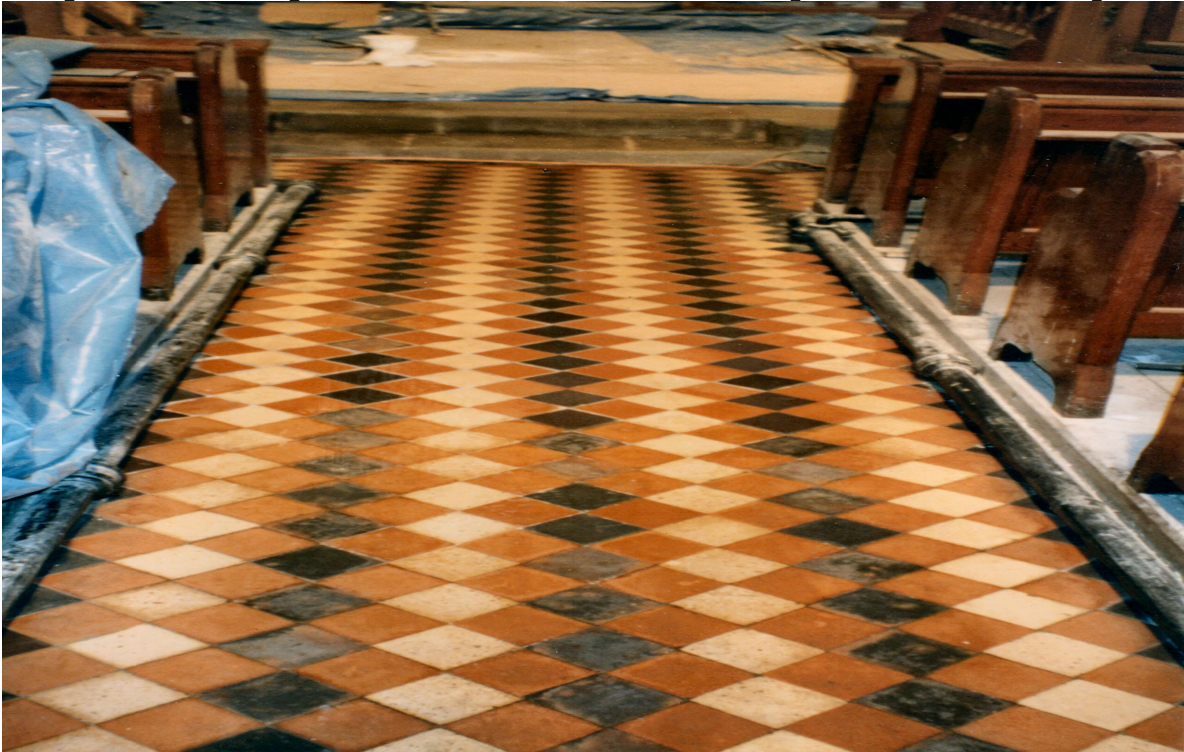
Some sections had been taken up and then re-laid out of sequence, we see that a lot on our contracts and it never ceases to amaze me that people re-lay the tiles in some cases quite well but neglect to put them in the correct sequence given that the pattern is a repeat and so there will be examples of the correct pattern.

Floor prior to cleaning the tiles lean to the right that is the original setting.

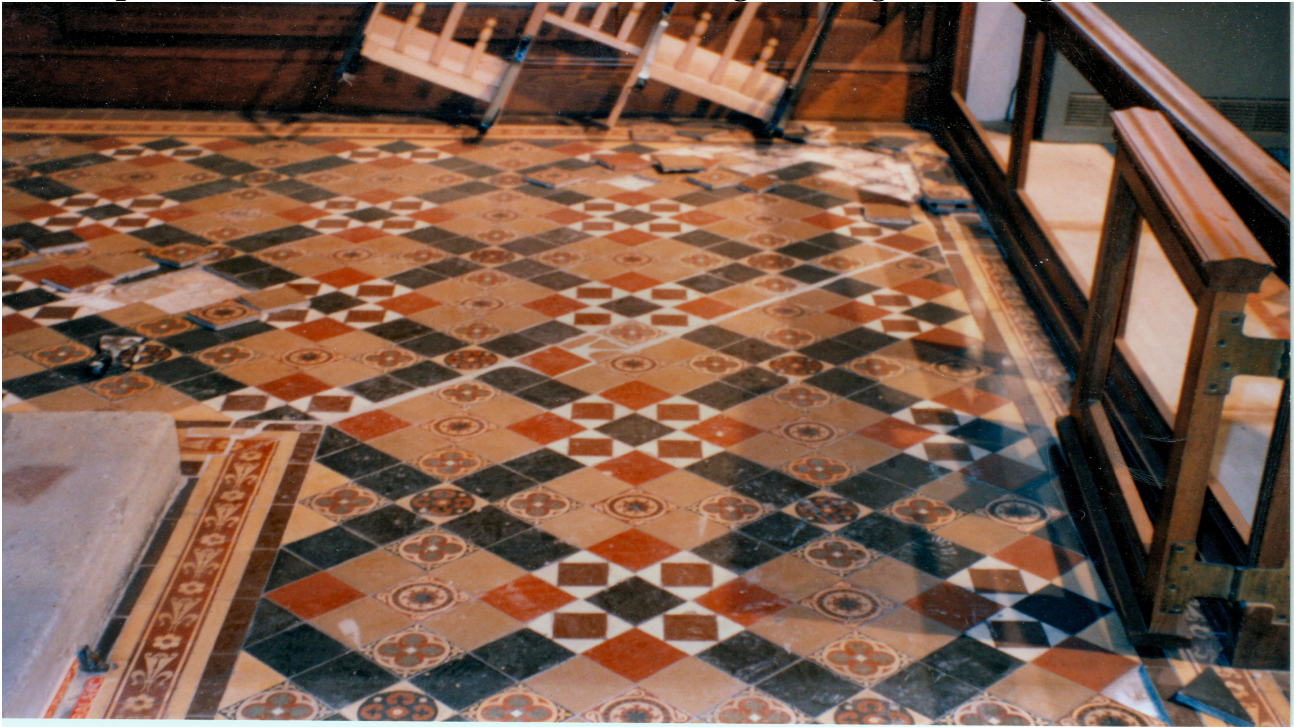
Below pictures of the altar floor tiles showing missing or damaged tiles.

The Victorian encaustic & geometric tiles on the altar floor prior to restoration.

The above tiles are a better stamp of tile than that used in the main aisles and are a finer finish the main aisle tiles are of a coarser finish and the colours are not as definitive.

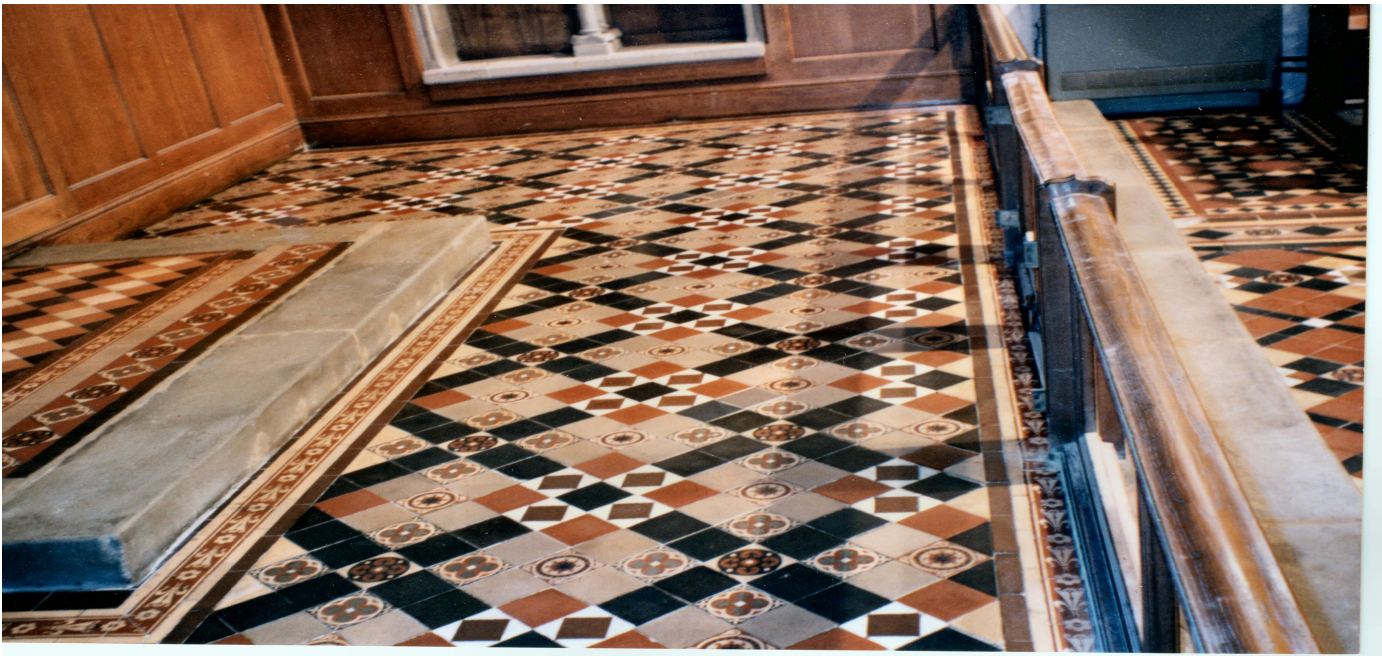
Victorian encaustic & geometric altar tiles restored.

Most of the restored sections were tiled using a variety of BAL (building adhesive ltd) products such as CTF 3 this was used anywhere the work was going to be slow and therefore needed a slower setting adhesive, Bal rapid was used in areas that could be fixed in a shorter space of time.

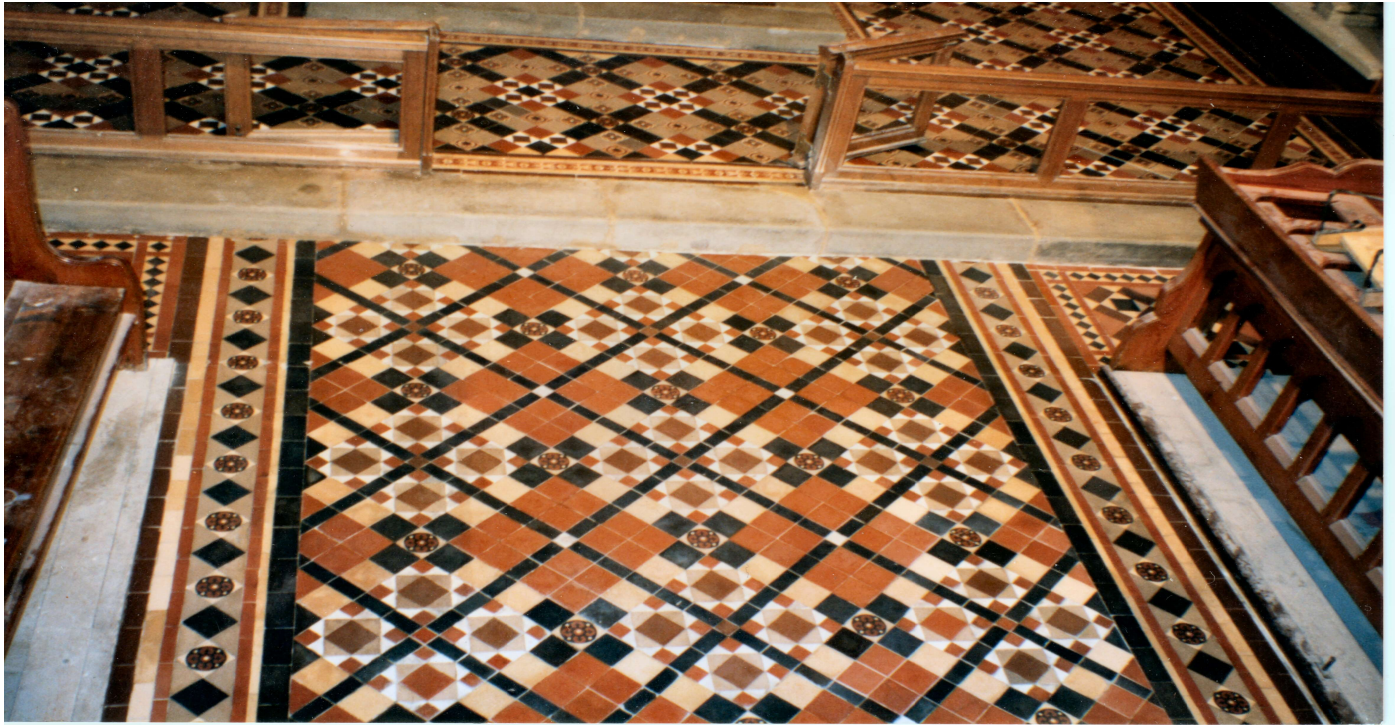
Victorian encaustic & geometric tiled floor fully restored.

To age the new tiles so they blended in we spread a mixture of anthracite grout over all of the tiles left it down overnight with the heating on full, the result after cleaning looked very good.

All the floor sections were cleaned at least five times and sealing took place a couple of day's later using Sheldon research Stone-glow sealer.
