## Llandudno N.Wales Restoration of a Victorian Geometric Floor.

A typical contract to restore a Victorian tiled floor badly damaged by thoughtless fitters installing central heating by cutting through the tiles instead of finding a way of routing the piping that doesn't cause damage.

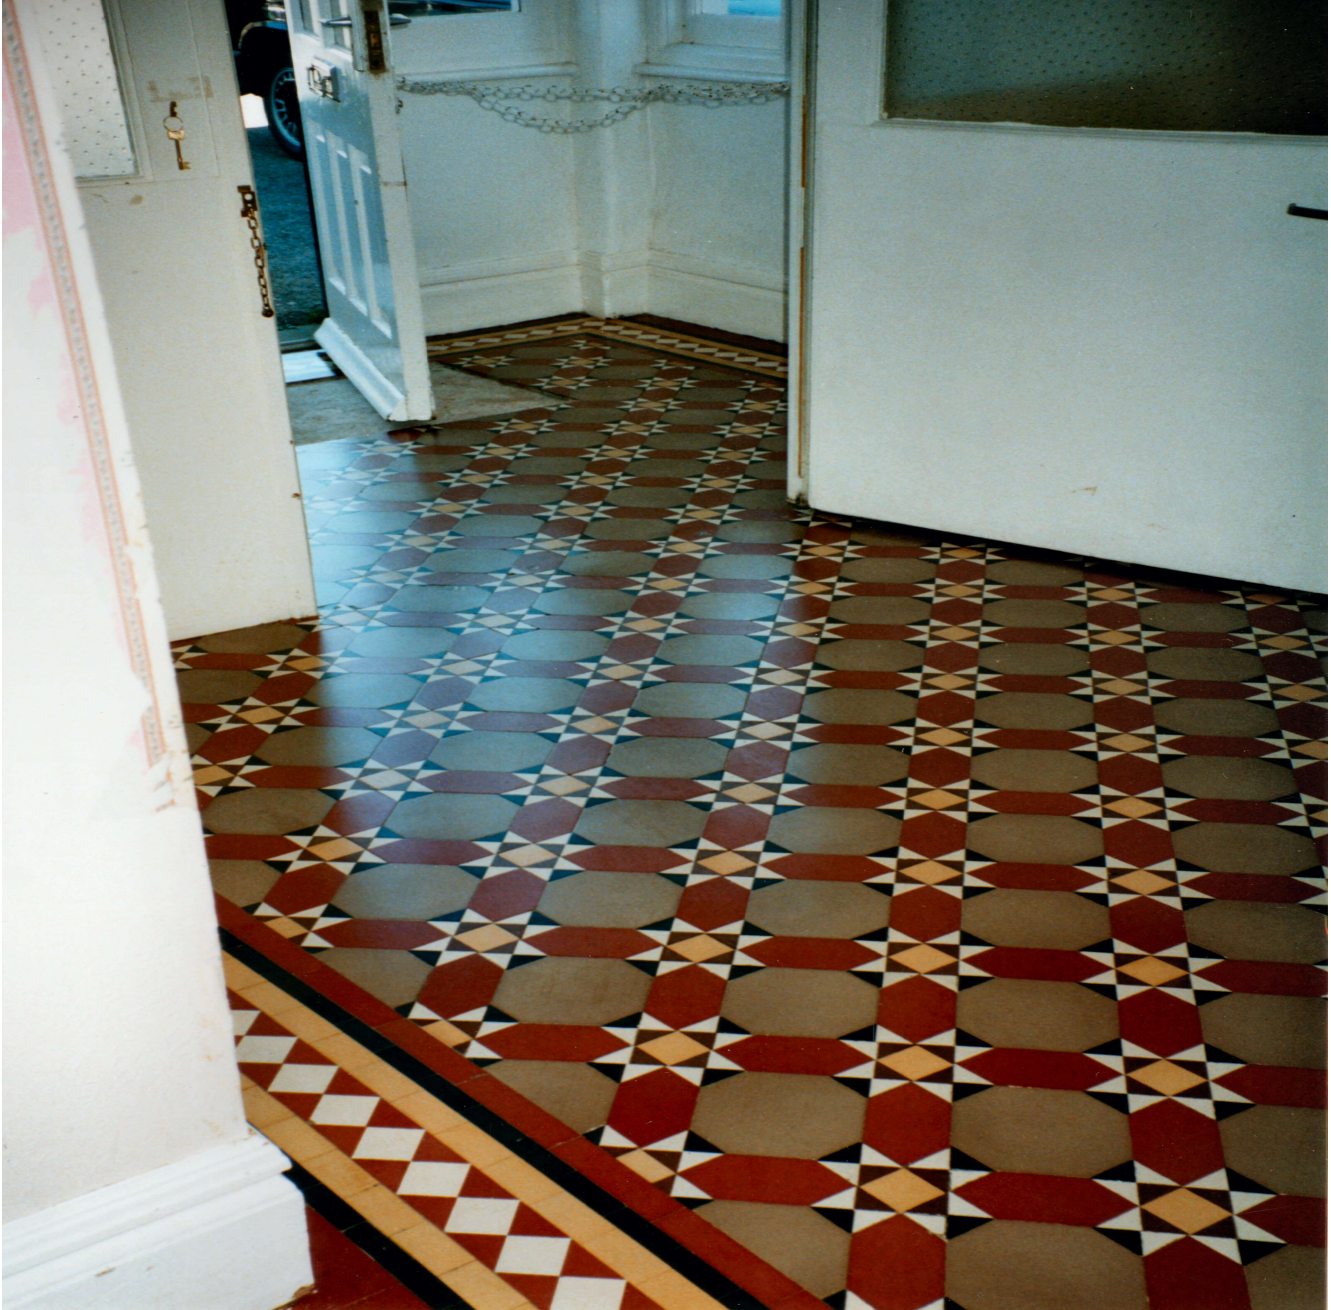
Stunning floor in Llandudno picture shows the matwell.

A section of tiles were lifted to make a matwell as this would keep the floor looking its best if muck etc was removed first.

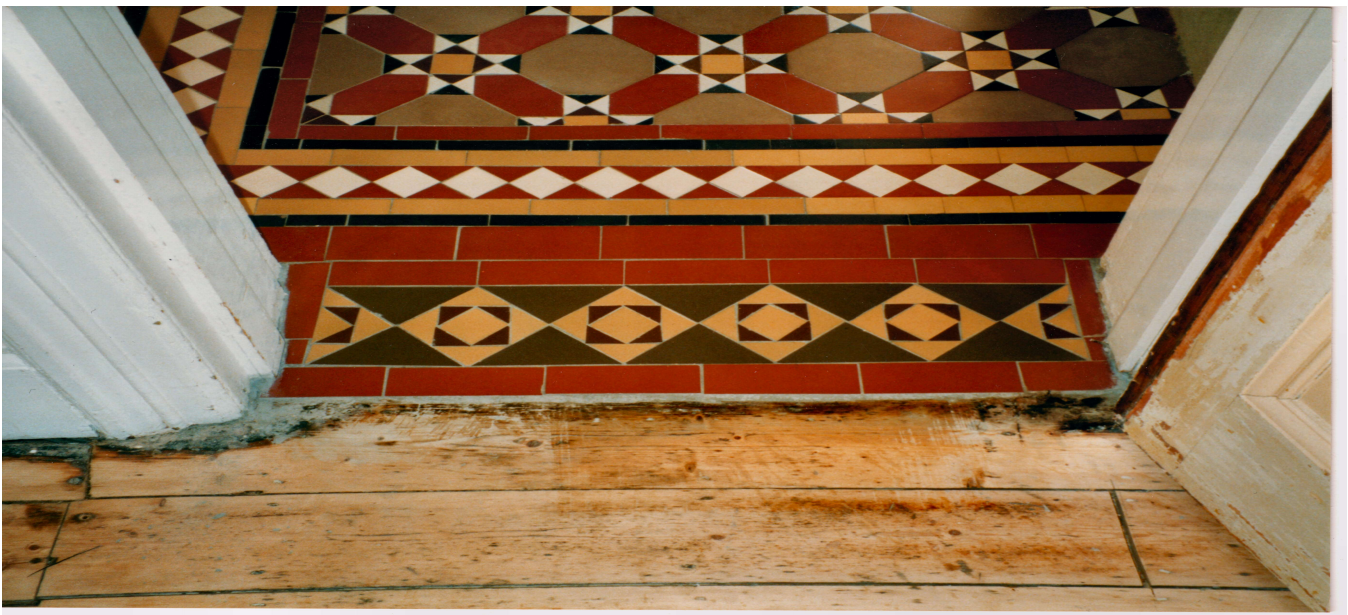
Restored threshold area.

The live pipes were sunk to a depth that a new screed could be installed over the piping and then a mixture of new & re-claimed tiles were fitted.

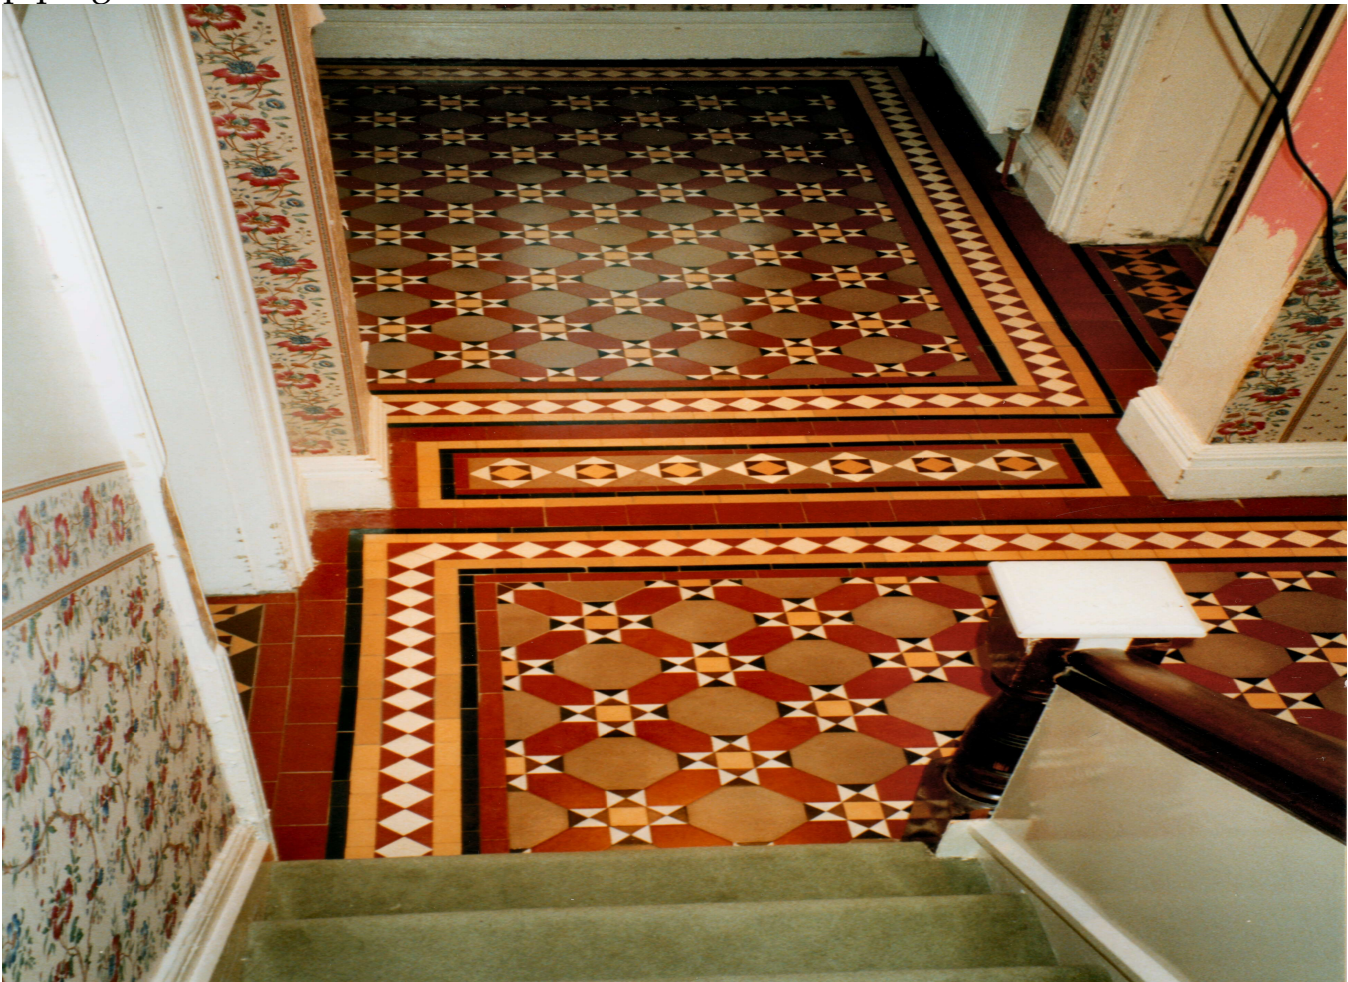
Stair View of restored Victorian Geometric Floor Llandudno.  
P4.

After restoring the main in-fill area and fixing other loose tiles I also cleaned a quarry tile dining room floor (no extra charge) mainly because I thought my clients would appreciate my efforts.
