Restoration of Victorian Encaustic & Geometric tiled floor work carried out at:
St Paul's Church, Irton, Holmrook, Cumbria. Grade 1 Listed building

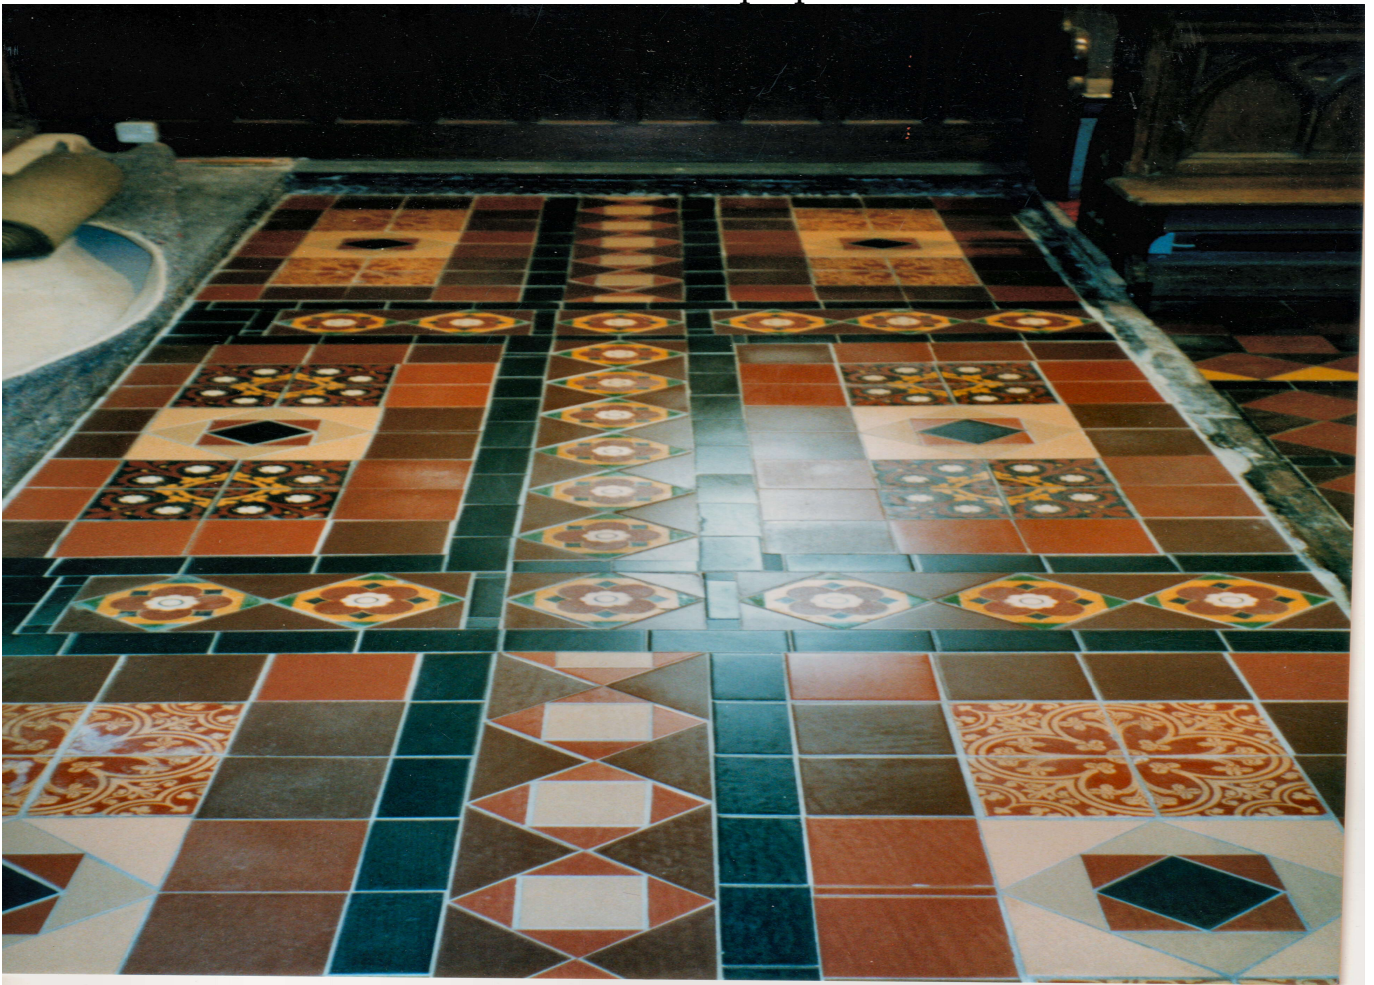
St Paul's Victorian encaustic & geometric tiles restored.
P5.

The finished floor looks stunning but 90% of the work is literally hidden or is done in a fashion that isn't seen because it is prep work.

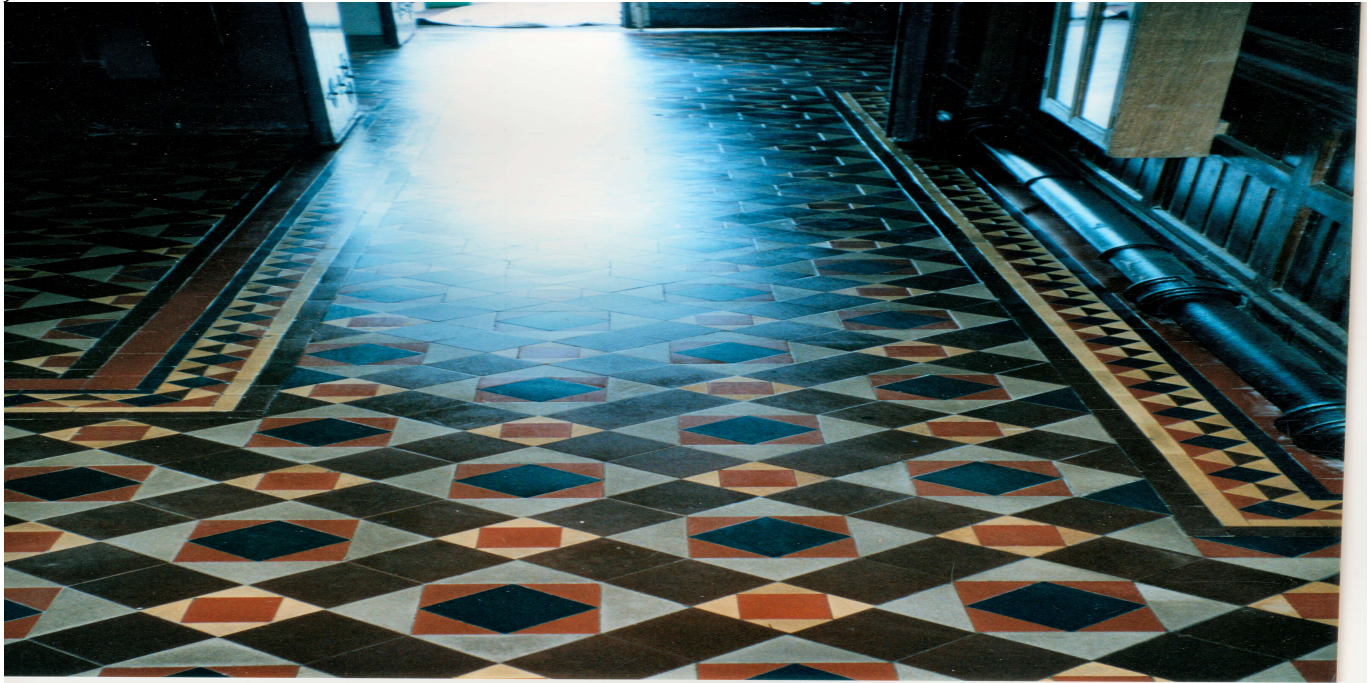
Below pictures showing the Fount tiles cleaned & restored those tiles had very little damage, the aisle pictures show the tiles restored most of the tiles here were just loose.

Main Aisle Victorian geometric tiles restored at St Paul's Irton

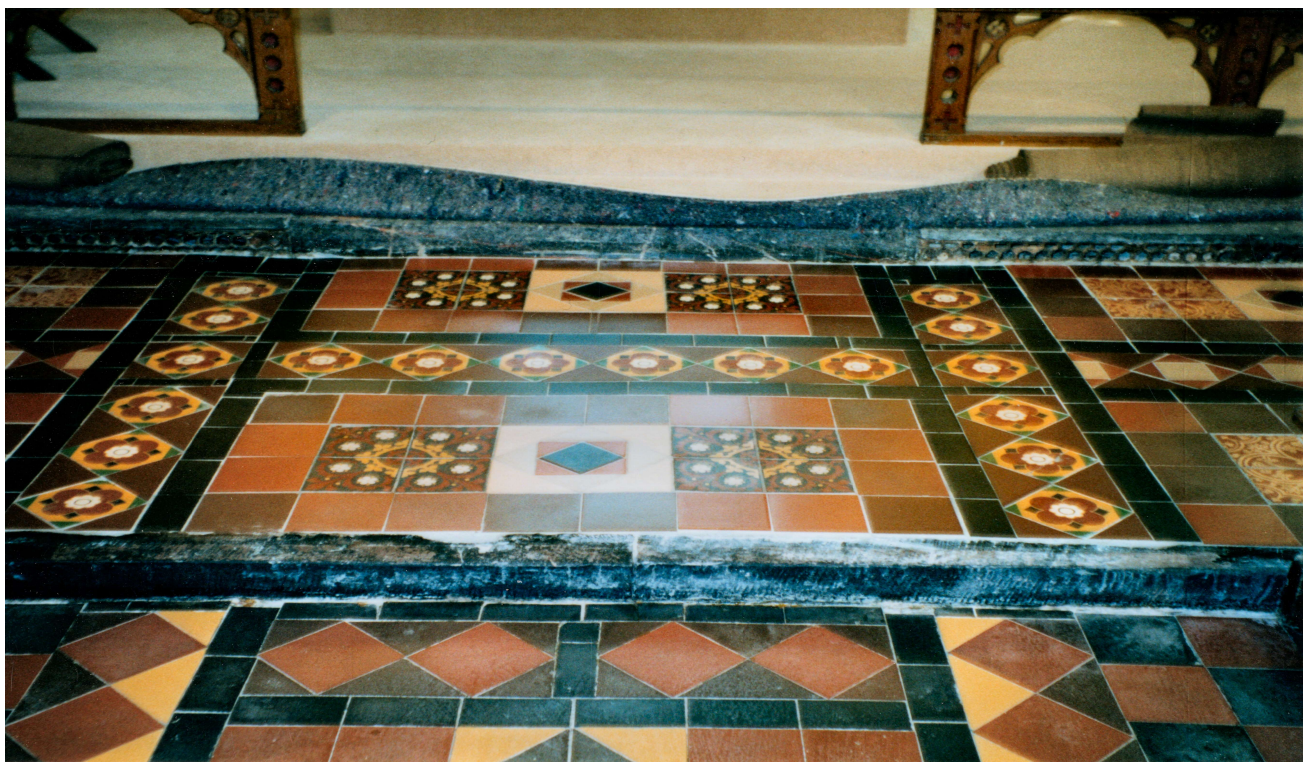
Re-positioned Victorian encaustic & geometric tiles restored at St Paul's Irton.
