Victorian Tiled floor Restoration Louth, Lincoln. Unlisted.

This contract was one of our usual type = Victorian tiled floor chopped up to fit central heating pipes.

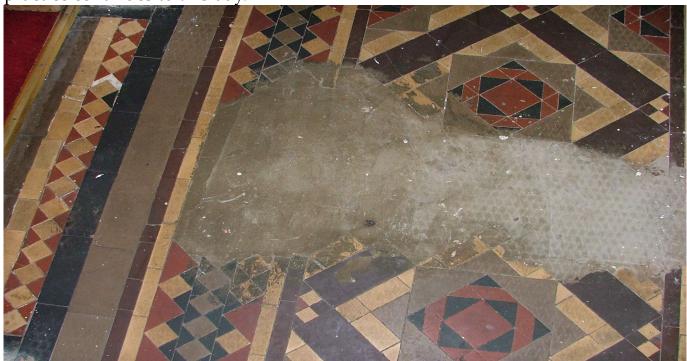
The pipe runs extends under the threshold tiles left hand side of pic.

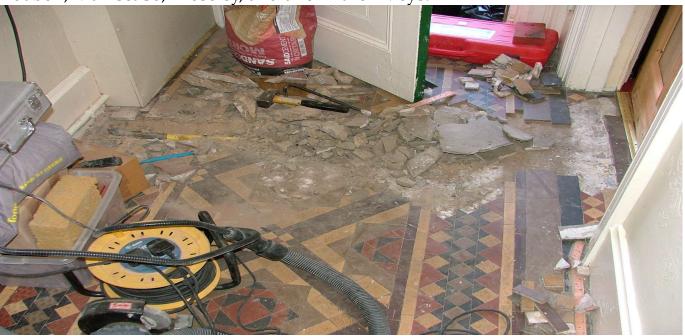
Pipe run being removed.

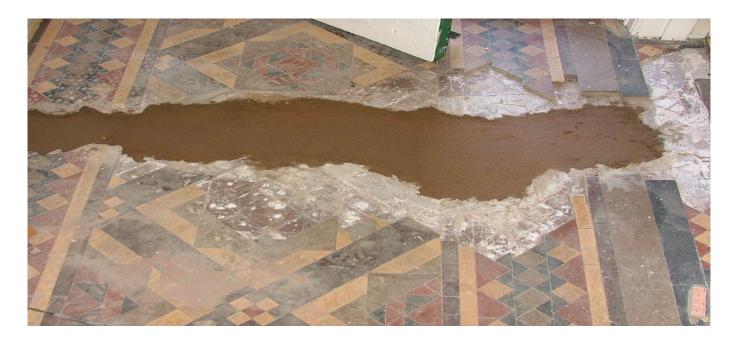
Pipe run screeded prior to tiling.

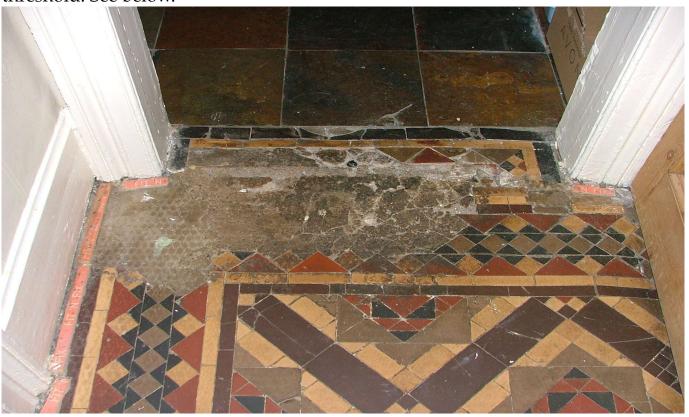
This floor had two pipe runs cut into it, the second run was across the kitchen threshold. See below.

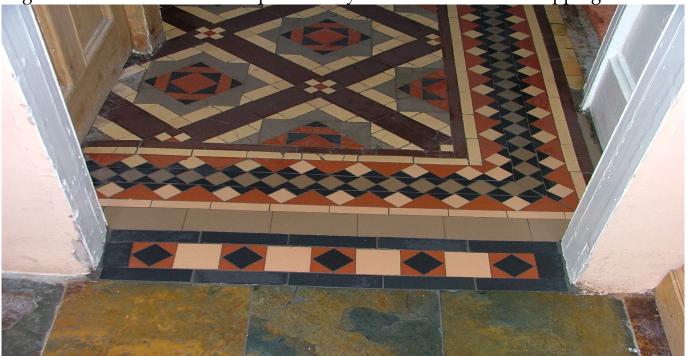
Kitchen pipe run restored.

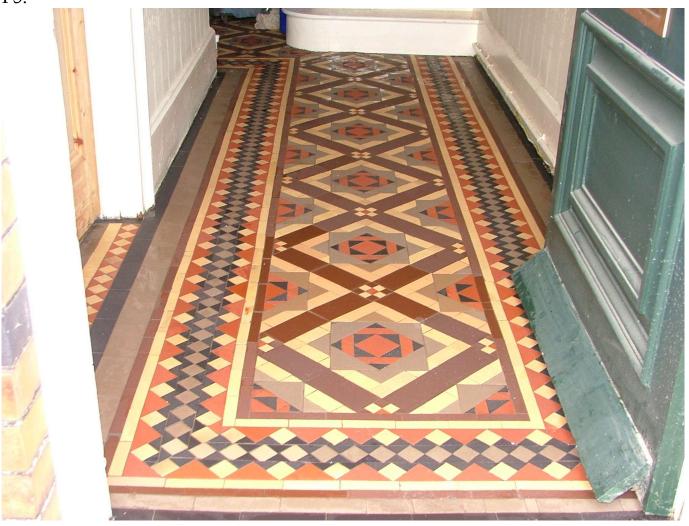
Louth floor fully restored.

Floor was cleaned using a low rpm scrubber and sealed using Dry-Treat which is a sealer that settles into the body of the tile rather than being a dwell on sealer which needs frequent maintenance = stripping -cleaning & re-sealing which will be dependent on how much foot traffic the floor has.

Dry-Treat will last at least 15 years before needing to be replenished and allows the floor to breathe which is very important with Victorian tiled floors as they are fixed into lime screed. It is generally acknowledged that this type of floor screed needs to allow air interchange as anything that stops that process can cause problems with the lime screed drying out too much which can cause shrinkage and heaving or tenting a common problem withy Victorian tiled floors.
