J.Brown restoration of Flood damaged 300 year old stone floor & a Victorian geometric tiled floor Grade 2 listed farmhouse.

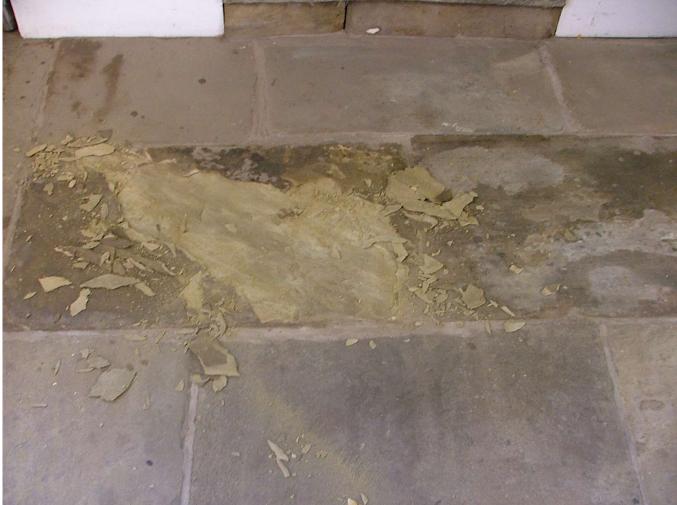
As a result of extensive flooding the stone floors had been covered in mud & water for some time and during the necessary drying out process with industrial de-humidifiers the stone floors had suffered with spalling in a few areas (spalling is when the layers of stone shed )

Picture showing spalling caused by flood damage and drying out.

The above picture also shows the near uniform grey colour the stone floor had become due to mud drying into the skin of the stone slabs.

We removed any loose/spalled stone layers and cut out damaged mortar from the joints we removed most of the mortar because it had been contaminated with flood water which did contain some sewage.

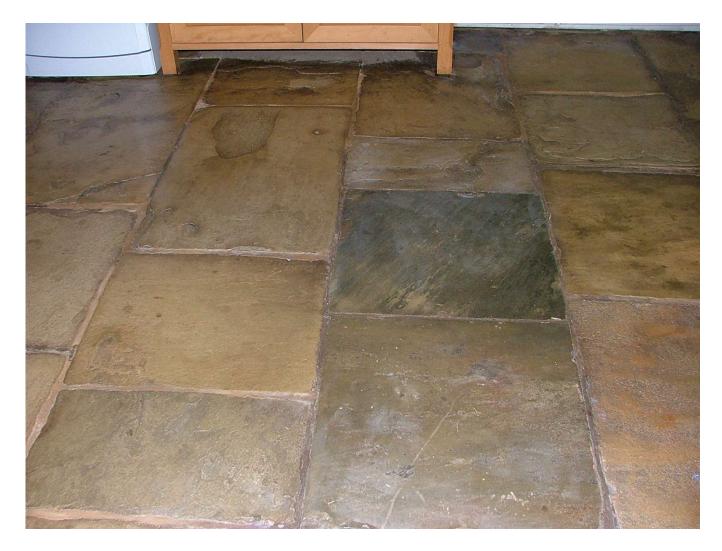
Stone floor restored & sealed.

Note the difference in the colour tones now that the dirt & grime from flooding has been removed.

This took more than 6 hours of cleaning to produce this effect.

The mortar was cut out using Exakt saws and Fein Supercut machine along with Vacuum attachments to prevent dust blowing everywhere.

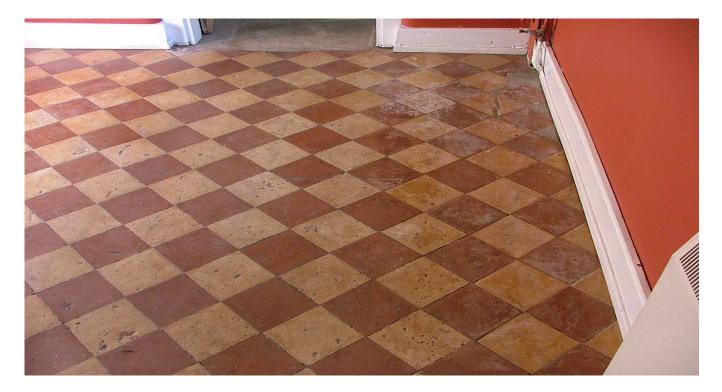
Victorian geometric tiled floor before restoration. Top right shows efflorescence.

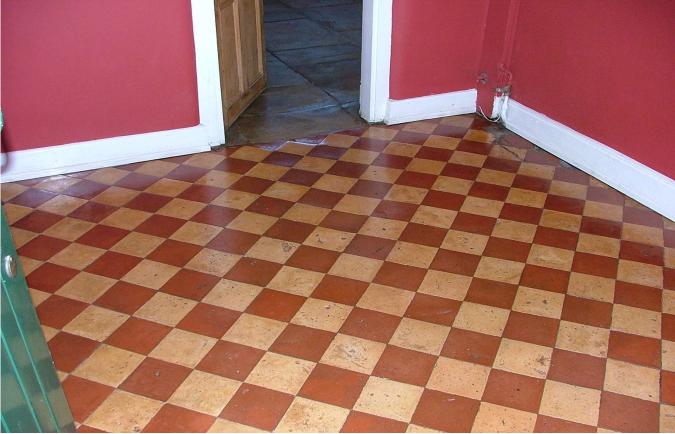
Victorian geometric tiles restored cleaned & sealed.
